Radford Army Ammunition Plant

MAIN MANUFACTURING AREA

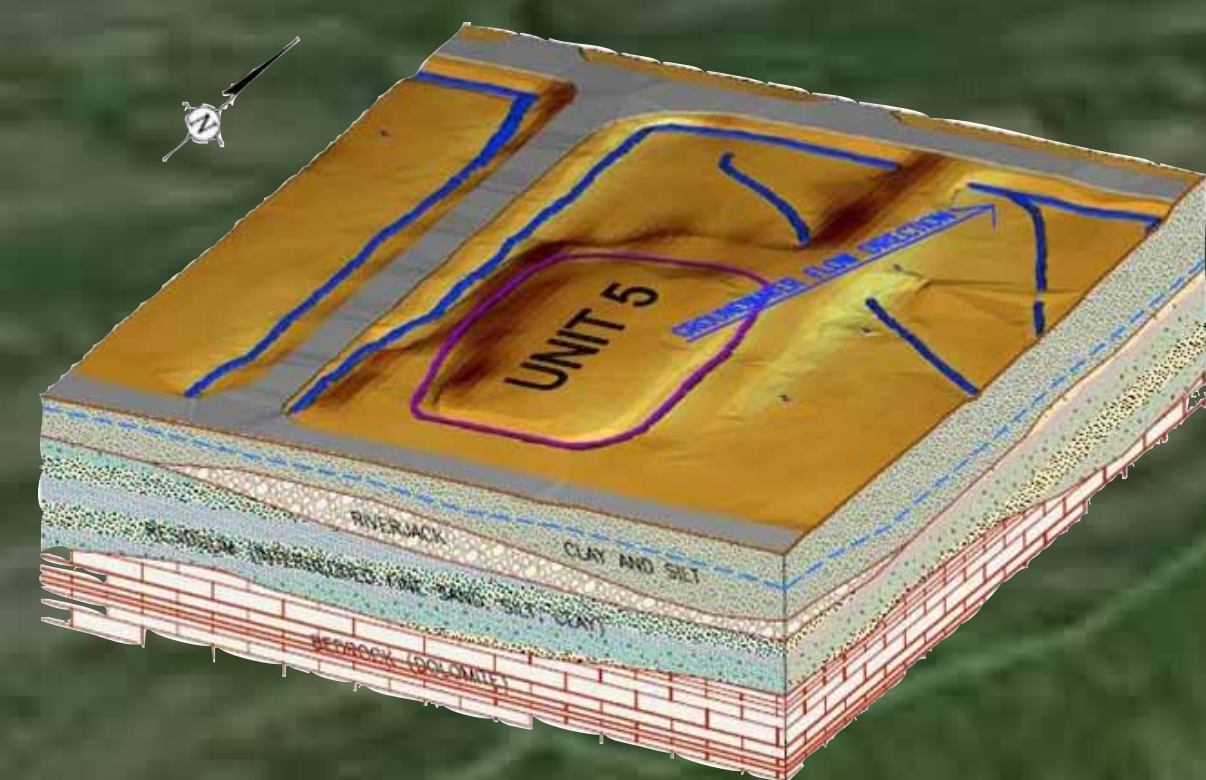
HWMU-5

- Limestone/dolomite bedrock covered by weathered and alluvial deposits
- Ground occurs in the unconsolidated material at approximately 15 to 20 ft bgs
- Groundwater generally flows to the northeast

- TCE present in soil and shallow groundwater at low levels
- Maximum detected concentration in soil was 120 ppb
- Maximum concentration in shallow groundwater was 11 ppb
- Area of TCE impact in groundwater confined to within 140 feet of HWMU 5
- Monitored Natural Attenuation was selected as the groundwater remedy. The permit was modified to include a Corrective Action Plan for the purpose of implementing the selected remedy.

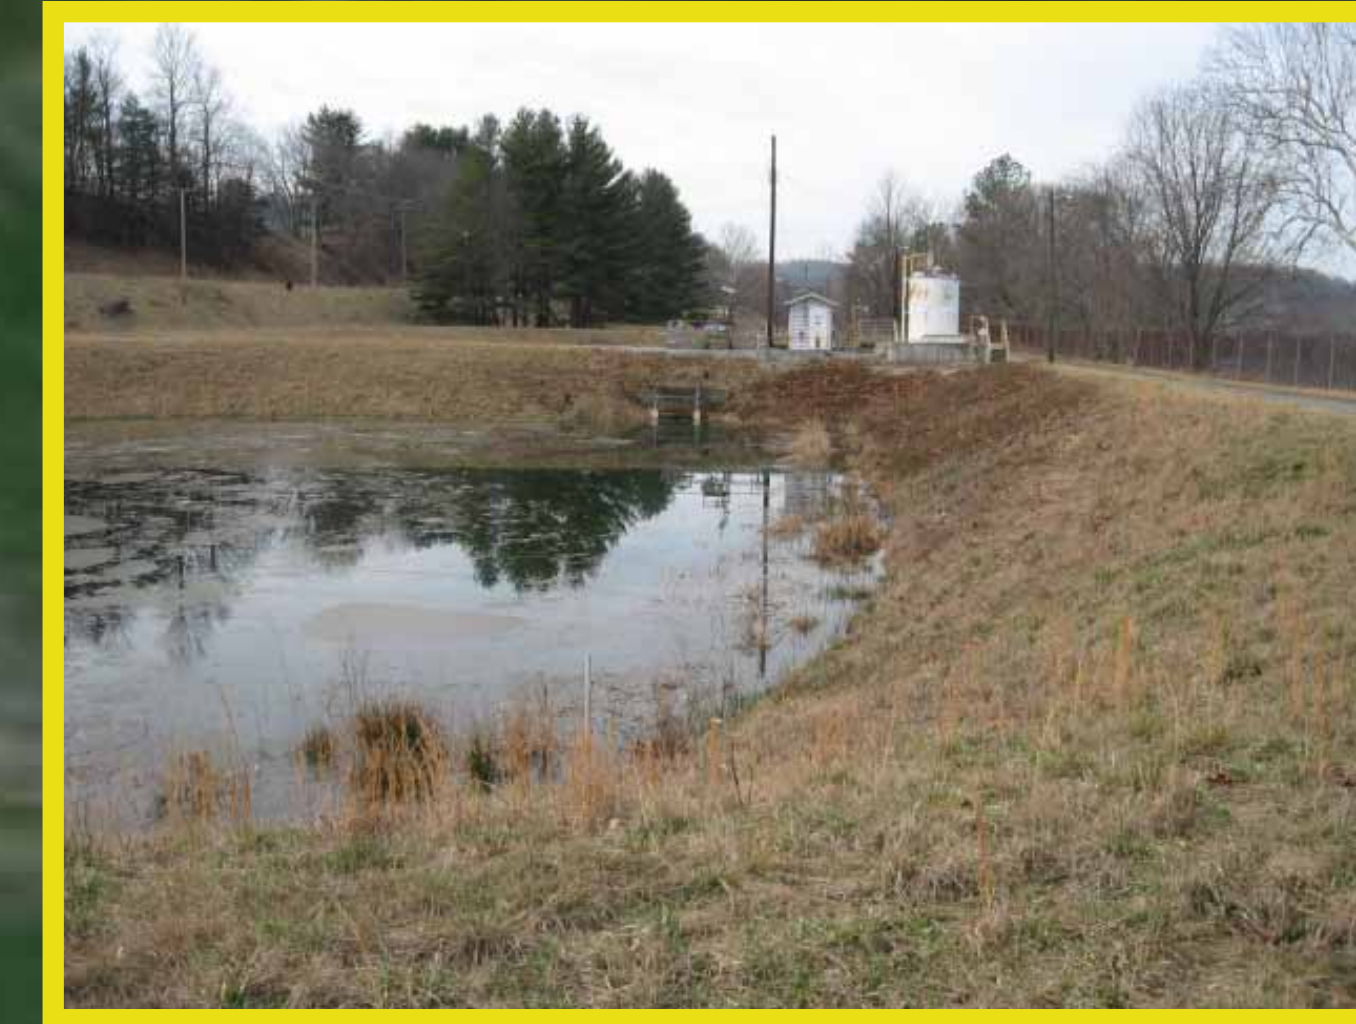
SWMU-31

- Comprised of three lagoons that served the potable Water Treatment Plant (WTP) and Power House No 2 since the 1950s
- Power House No. 2 discharged ceased in 1980s
- Received water carrying fly and bottom ash
- Currently receives filter water backwash from WTP

- Potential risks to human health under current land use (military / industrial) are within the USEPA generally acceptable risk range
- Low potential for ecological impacts associated with surface water and sediment in primary lagoon; however, risk is minimized due to small area that is affected (~0.11 acres)
- Ecological risk drivers in sediment were very low levels of dioxin and DDT
- Ecological risk drivers in surface water were aluminum, barium, iron, lead, endosulfan II, endrin and pyrene
- Concentrations of constituents in soil are within background levels or less than residential screening levels
- Concentrations of compounds detected in groundwater are less than MCLs or within background levels
- Data Gap groundwater sampling confirmed that benzo(a)pyrene is not present in groundwater

- RFI completed in July 2007
- Data Gap groundwater sampling conducted in 2008
- Final RFI Addendum recommending No Further Action was submitted in October 2009 and approved by VDEQ and USEPA on October 23, 2009

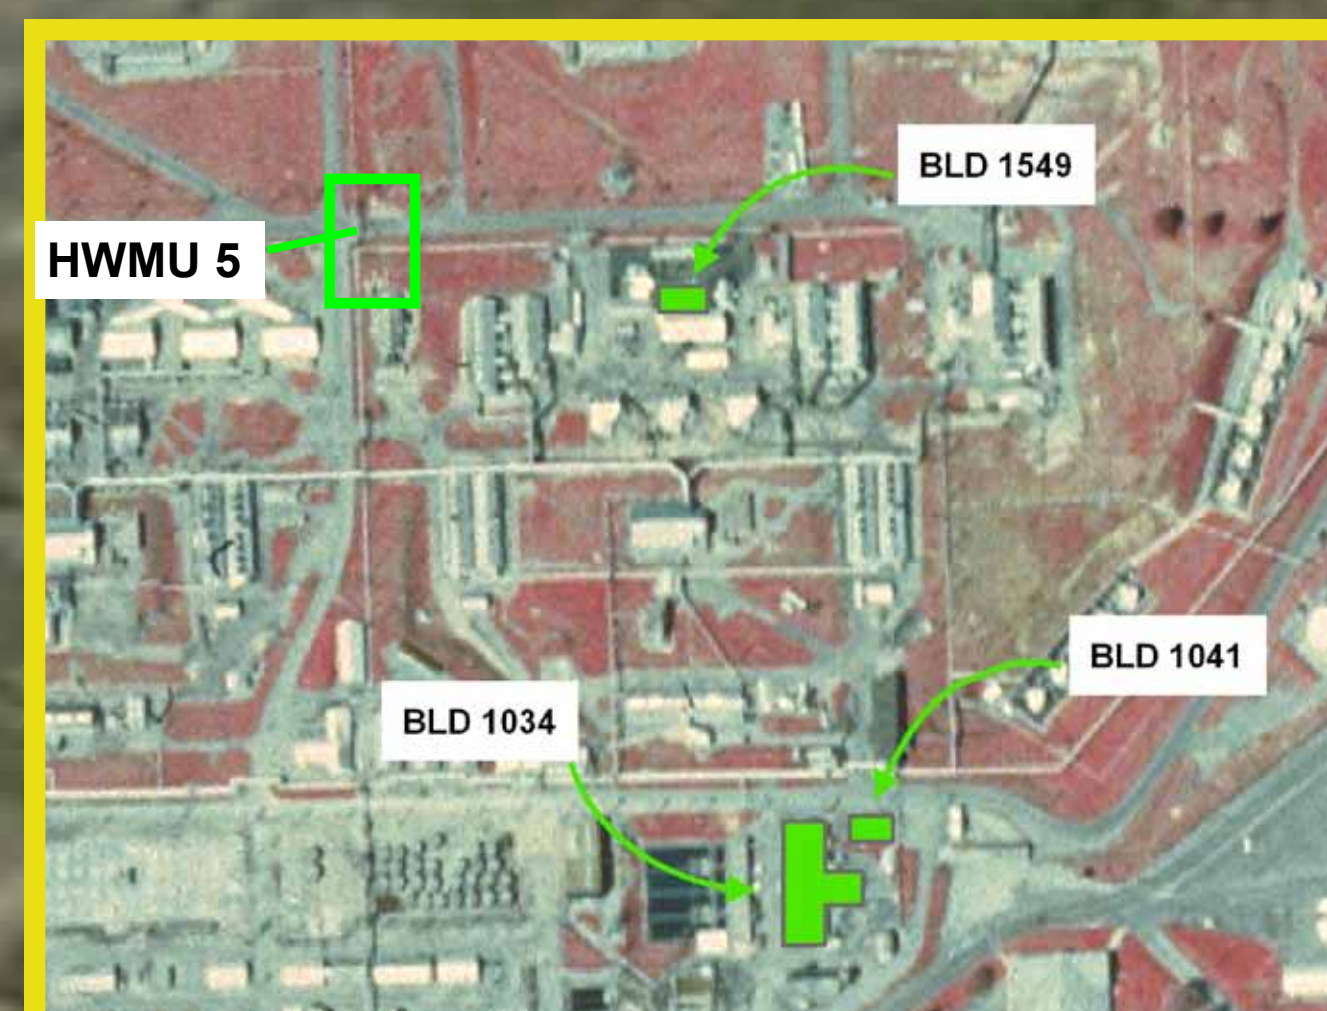
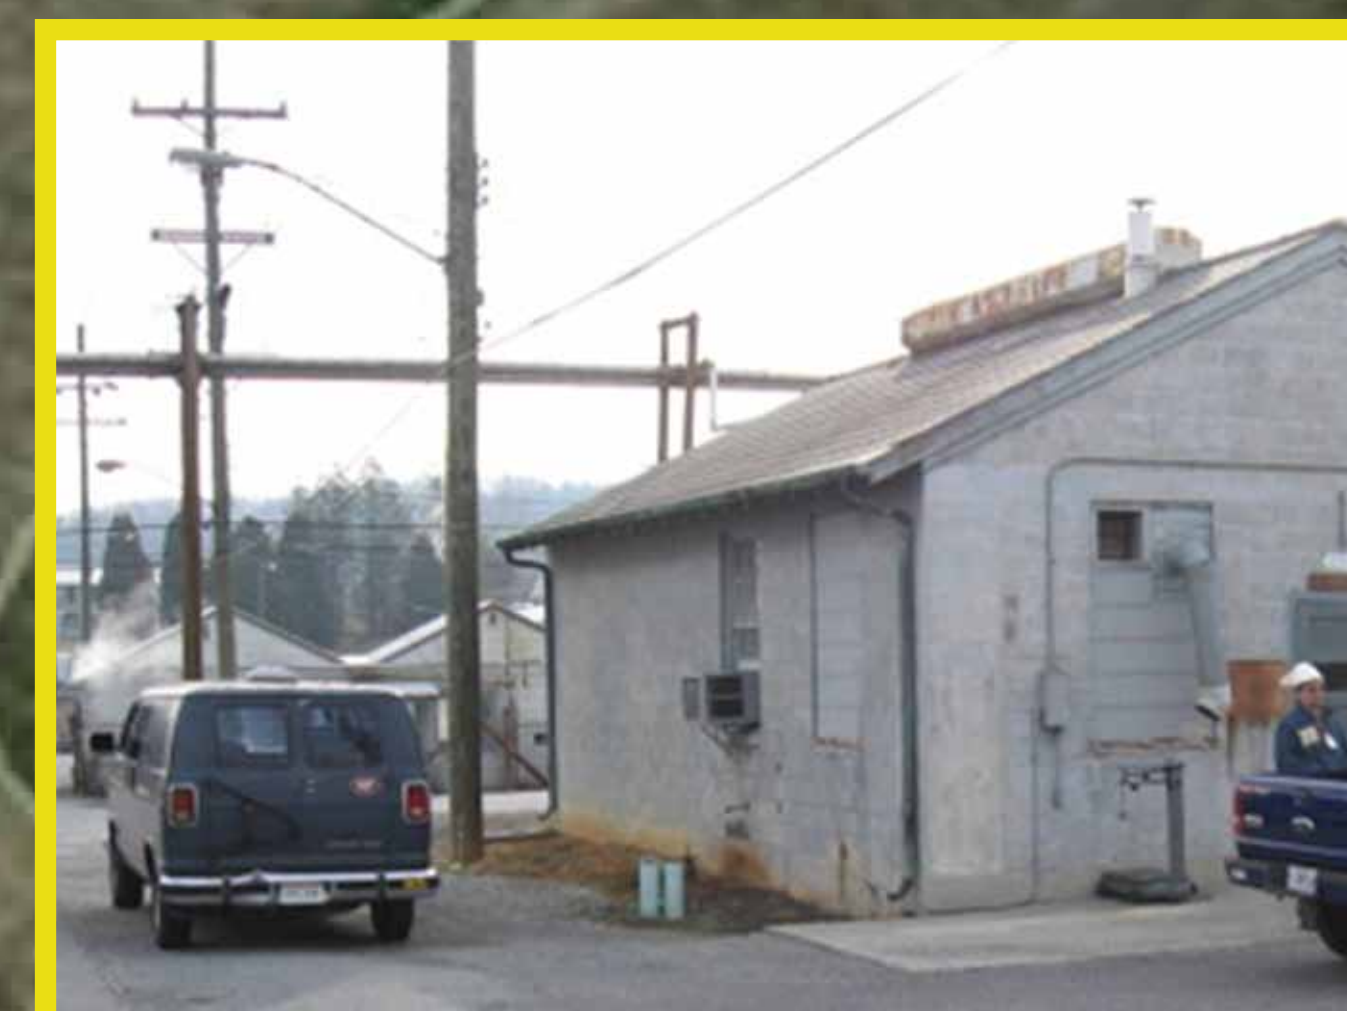
Buildings 1549, 1034, 1041 (RAAP-047)

- Building 1549: Maintenance Shop
- Building 1034: Electrical Shop; former Nitrocellulose Laboratory
- Building 1041: Scale Storage/Shop; involved former scale cleaning/degreasing
- Buildings have reported historic chlorinated solvent use however no releases were ever reported

- Soil Gas - TCE and chloroform were detected in soil gas.
 - Chloroform is related to leaking water supply lines
 - TCE concentrations were less than screening levels except at one location east of Building 1041

- Soil - No detections above industrial screening levels
 - Isolated detection of PCBs at one location south of Building 1041 above residential screening level
- Groundwater – Metals present in groundwater are associated with high turbidity levels in samples
- Potential risks to human health under current (military/ industrial) and future (hypothetical residential) are within the USEPA generally acceptable risk range
- Final RFI report recommending No Further Action was submitted in September 2009 and approved by VDEQ and USEPA in October 2009

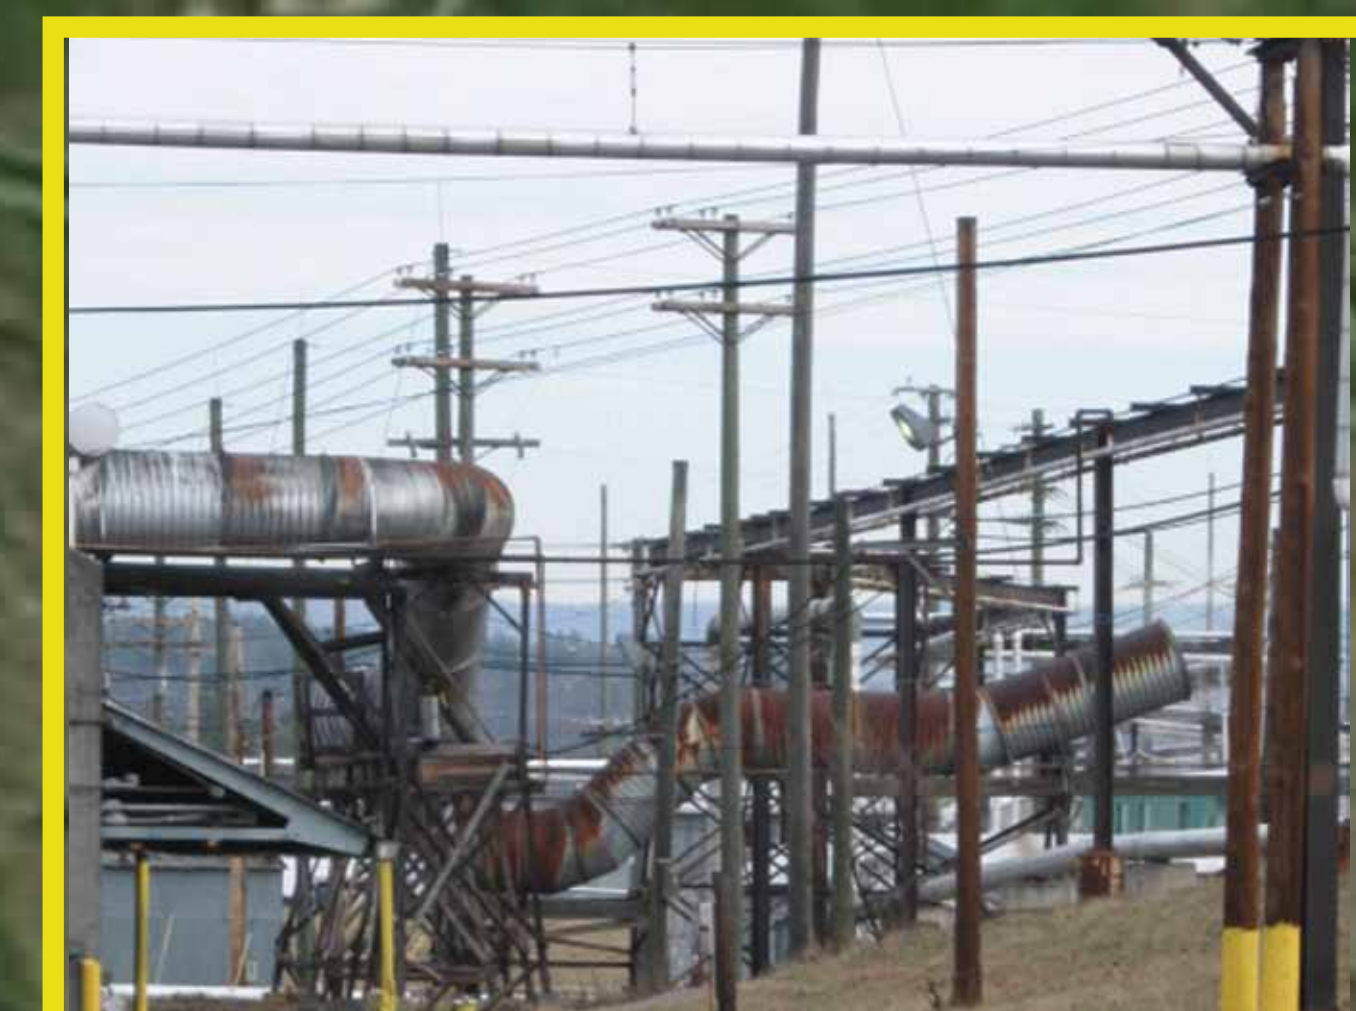
AOC A

- Former unlined surface drainage ditch identified in the mid 1980s
- Listed for site screening in the 1990s by which time a concrete swale had been installed

- Site Screening Process identified dinitrotoluene and PCBs in soil greater than screening levels
- RCRA Facility Investigation (RFI) was conducted in 2008 to delineate dinitrotoluene and PCBs in soil
- Dinitrotoluene and PCBs are limited to surface soil in small area, capped by a concrete stormwater conveyance
- Potential risks to human health under current (military/ industrial) and future (hypothetical residential) are within the USEPA generally acceptable risk range
- Final RFI report recommending No Further Action was submitted in September 2009 and approved by VDEQ and USEPA in October 2009
