Project Photos

BLA and IAA Response Action
Photos
RFAAP-NRU

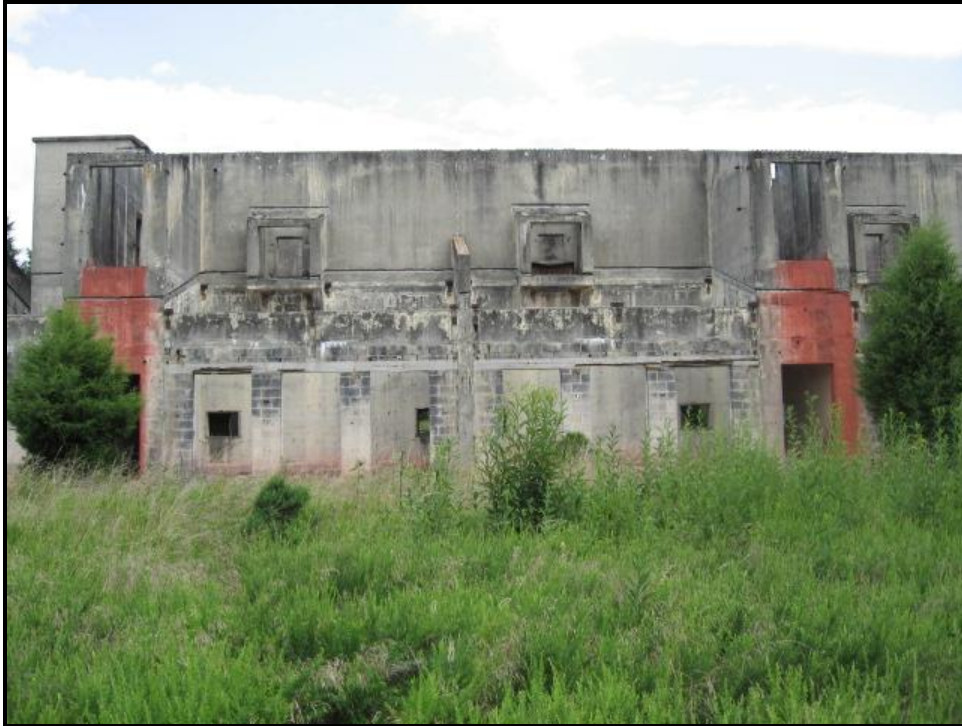
Bag Loading Area
Building 404 prior to
removal action. October
2009.

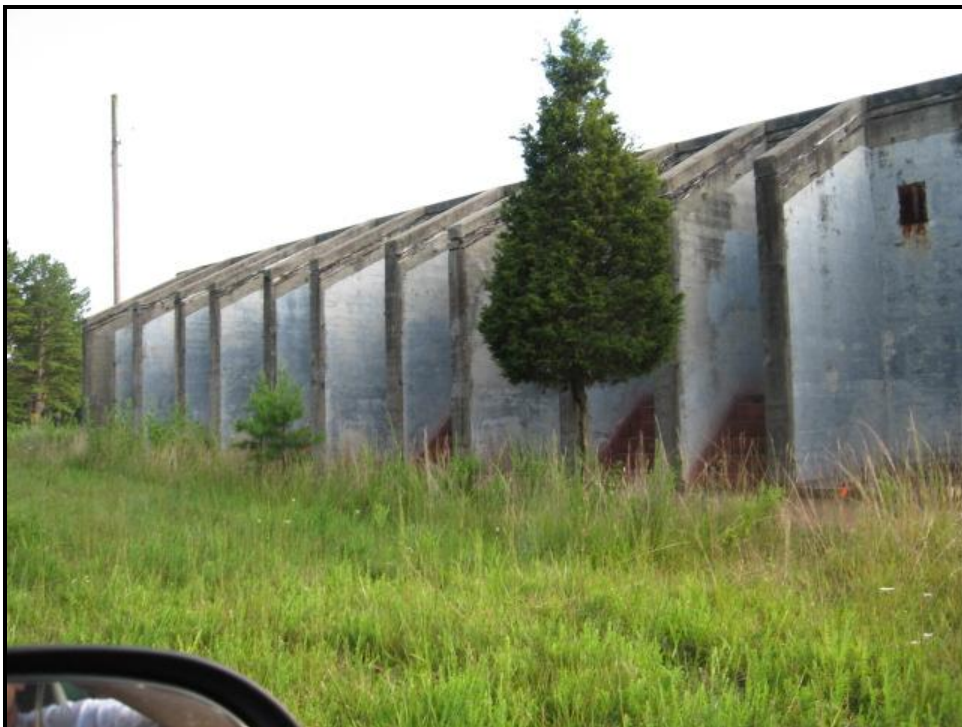
IAA Building 8102-1
prior to removal action..
October 2009.

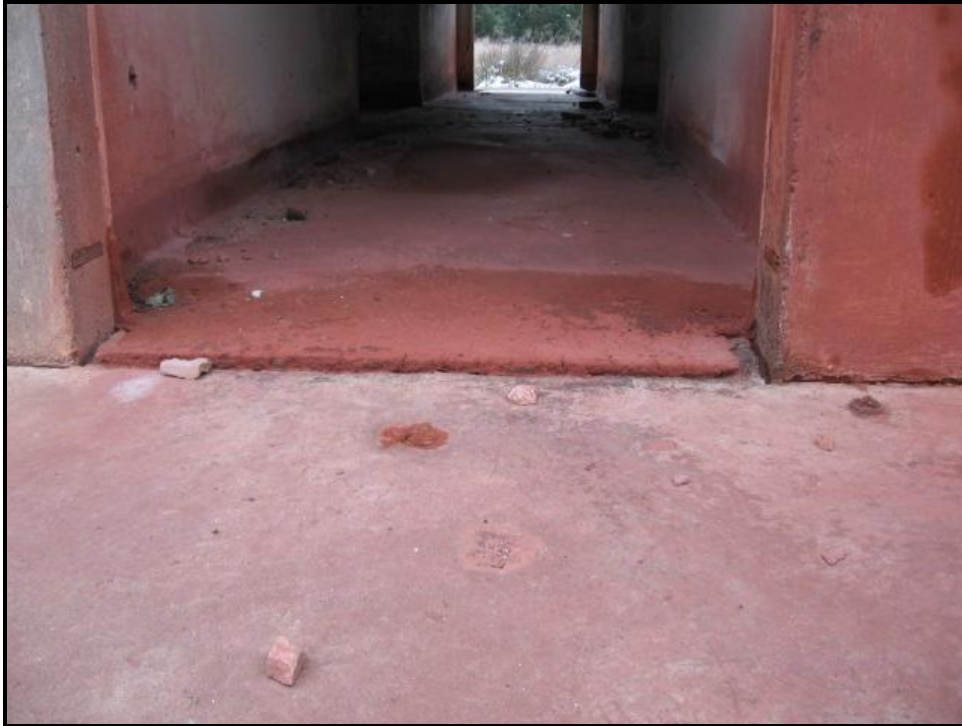
View of conductive
flooring material inside
BLA Building 404.
October 2009

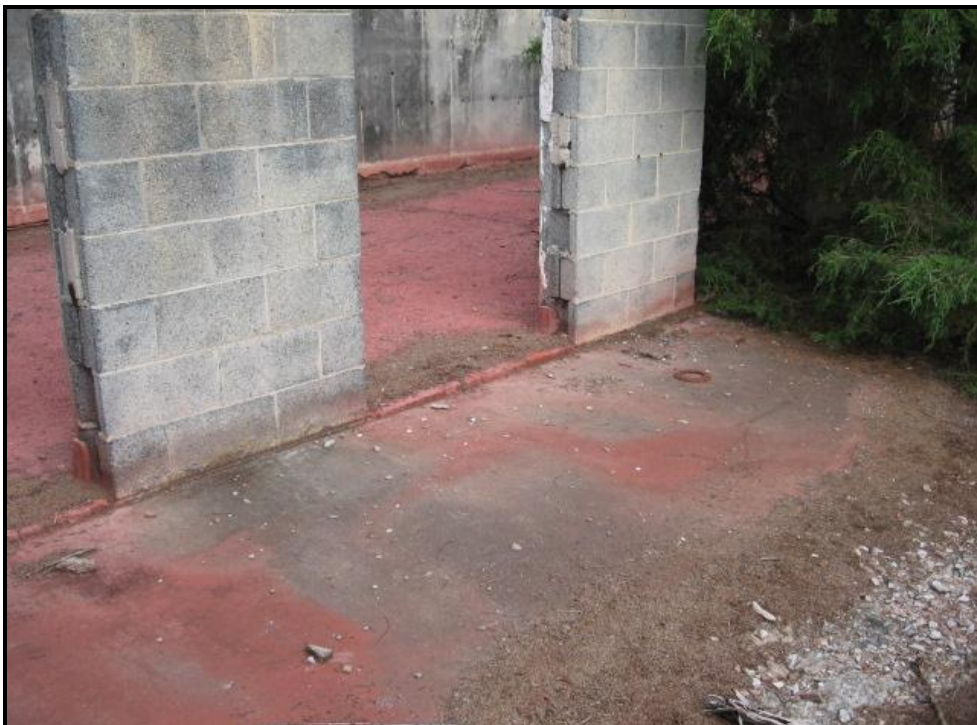
View of conductive
flooring stains on
sidewalk at BLA
Building 405. October
2009.

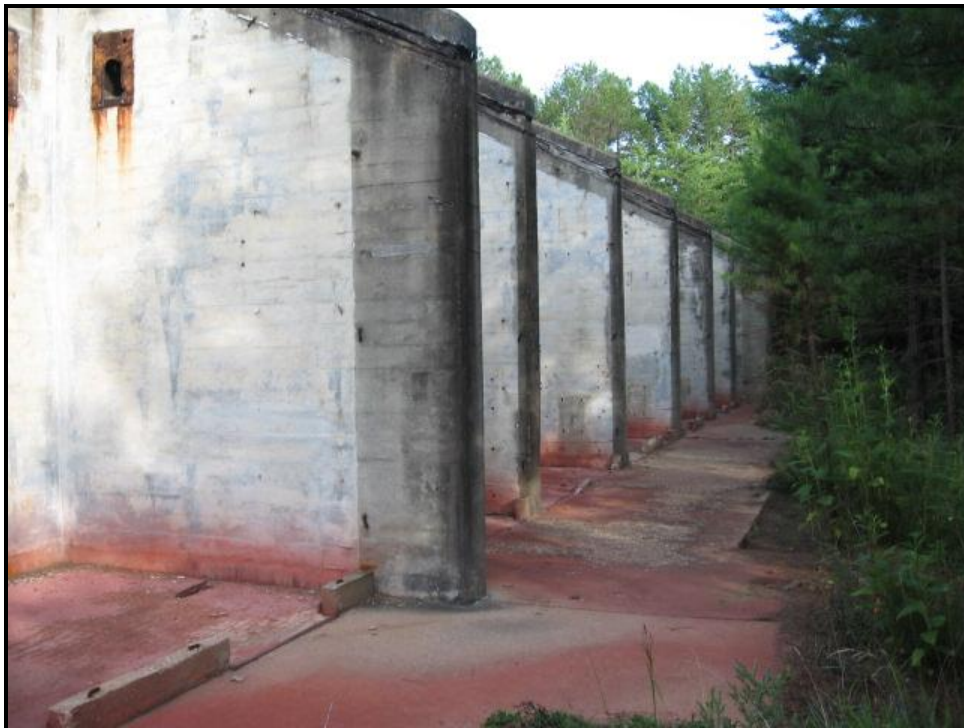
Typical IAA building
prior to removal action.
August 2008.

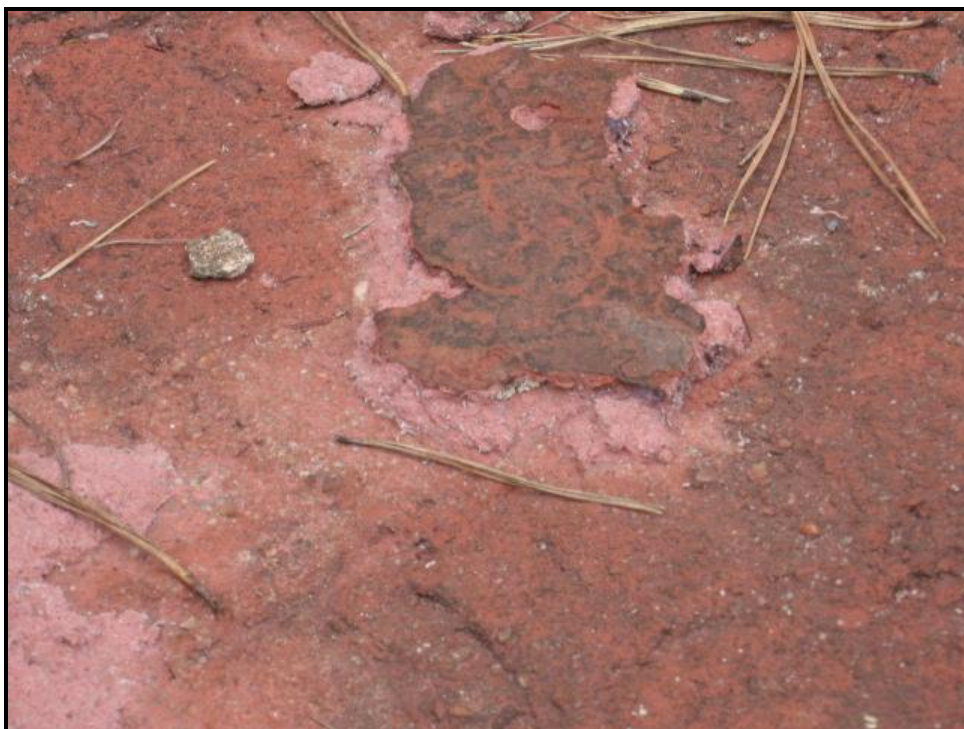
Close-up view of
conductive flooring
material. August 2008.

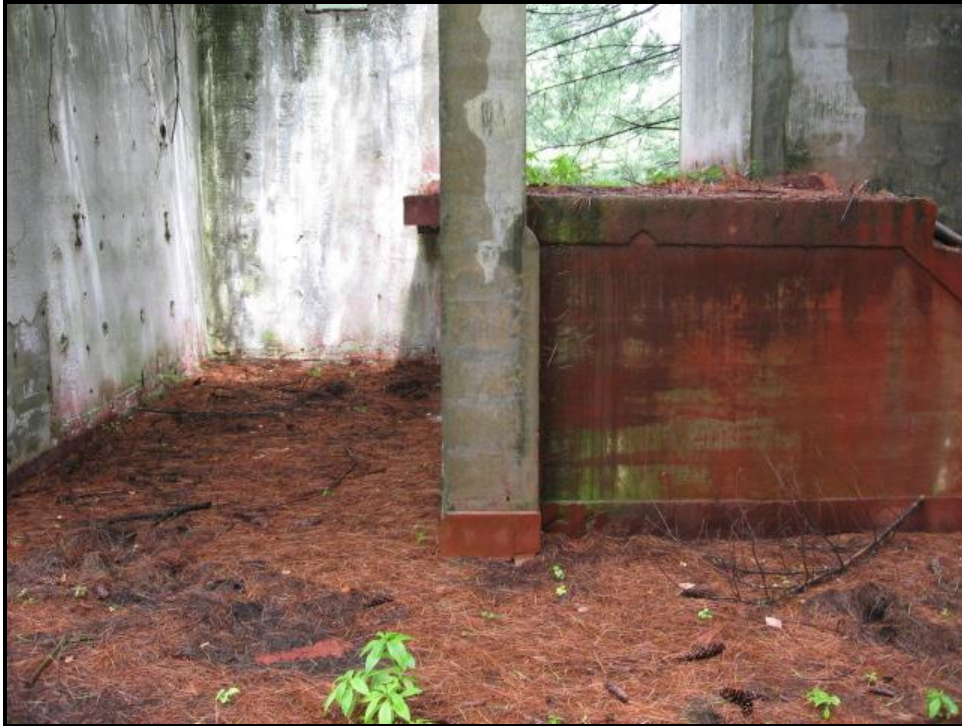
View of IAA Building 1
from October 2009.

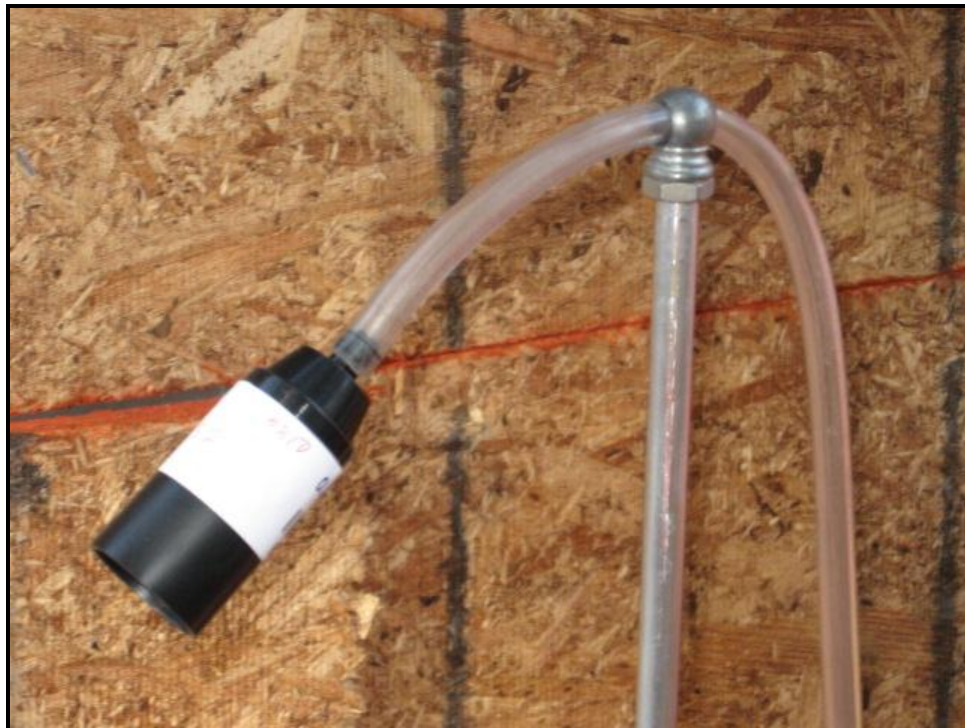
View of typical air sampling (asbestos) cartridge used during abatement work. This sample location was inside the entrance/exit to a decontamination unit. January 2011.

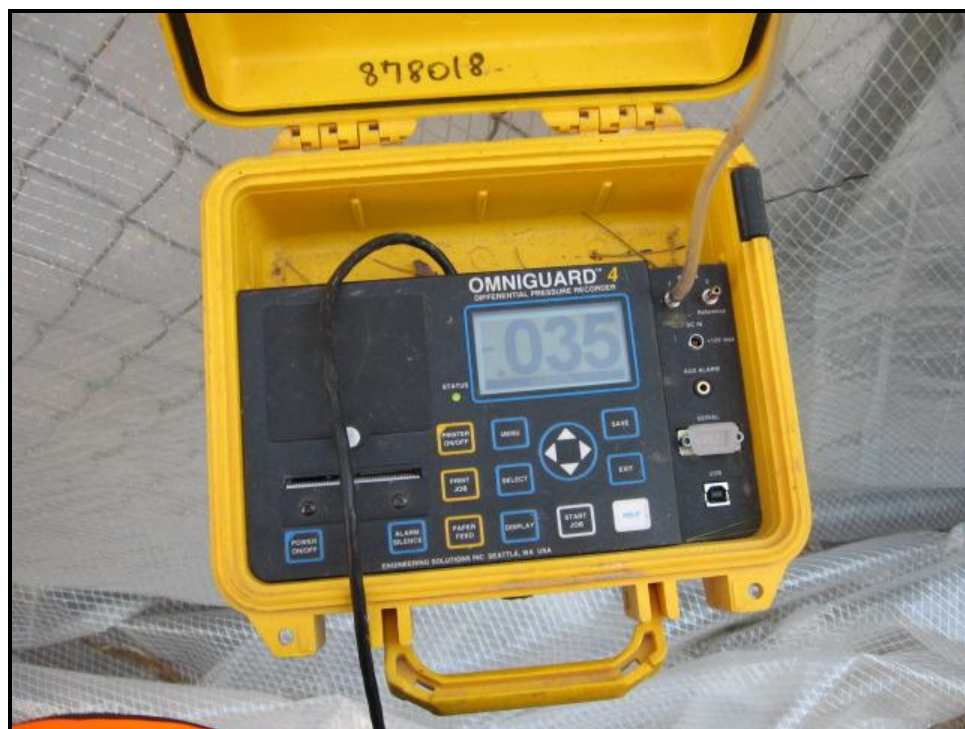
Digital manometer used to demonstrate negative air pressure in asbestos containment during conductive flooring removal event. February 2011.

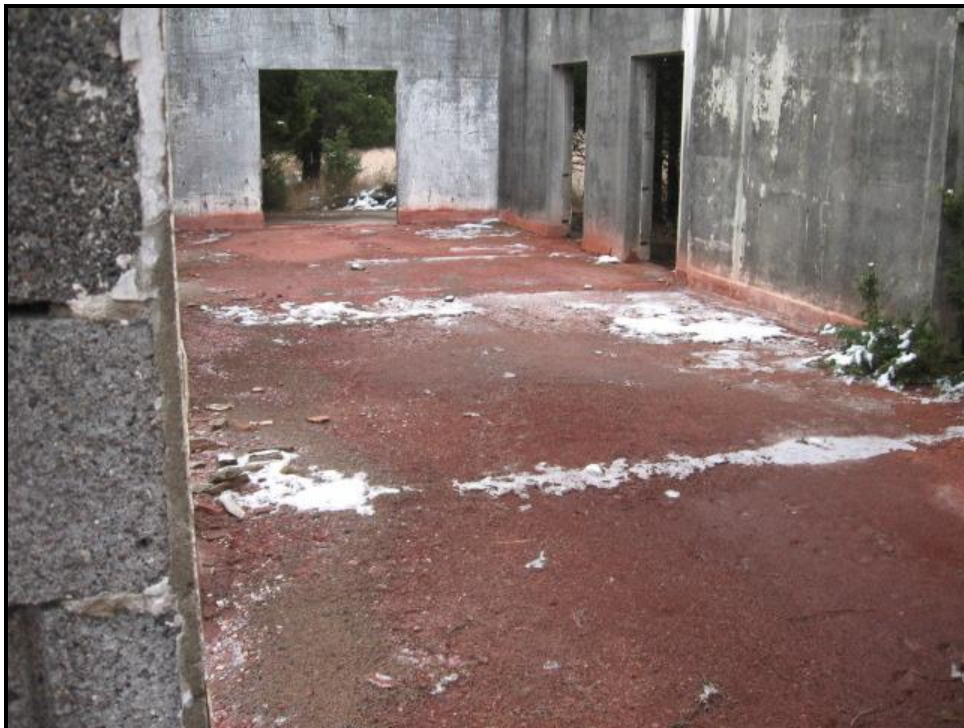
View of conductive flooring inside Building 404. January 2011.

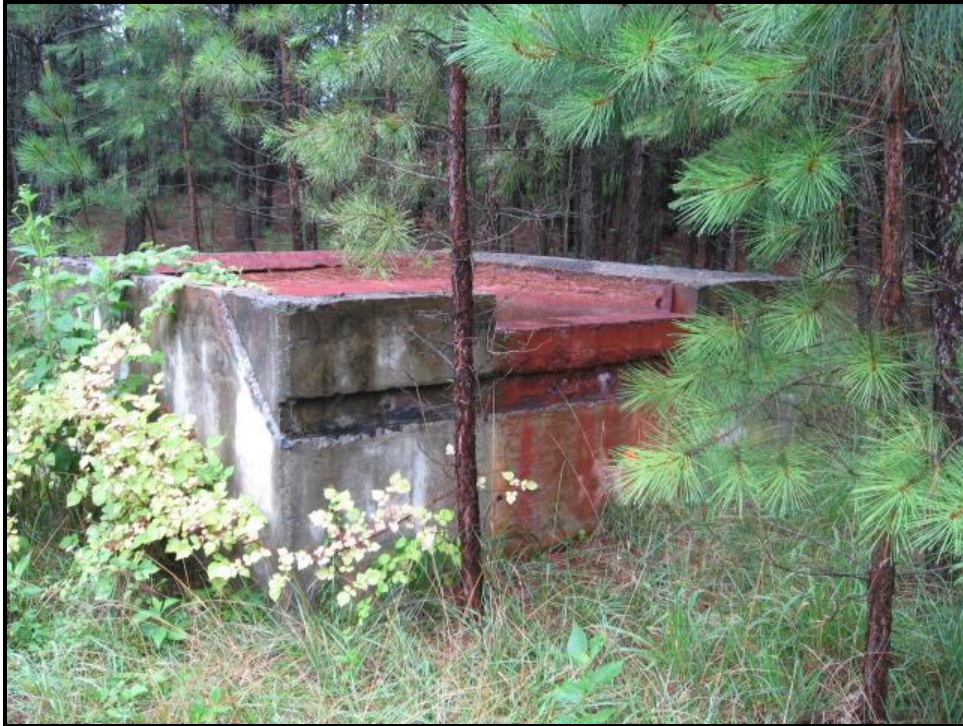
View of IAA Building
565B from August 2008.

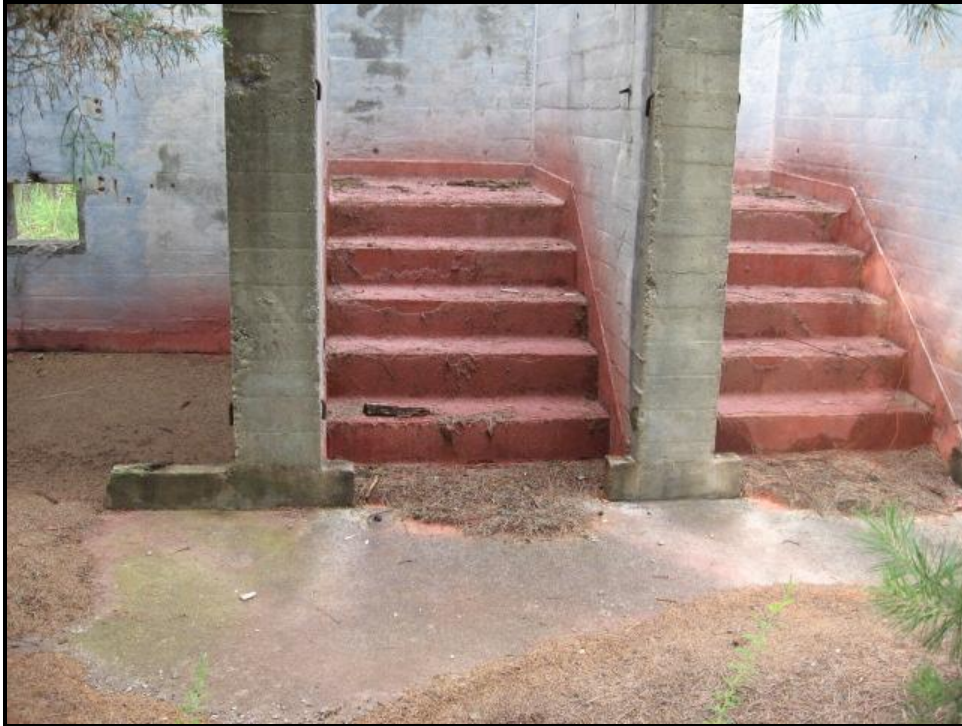
Conductive flooring
inside Building 8102-4.
August 2008.

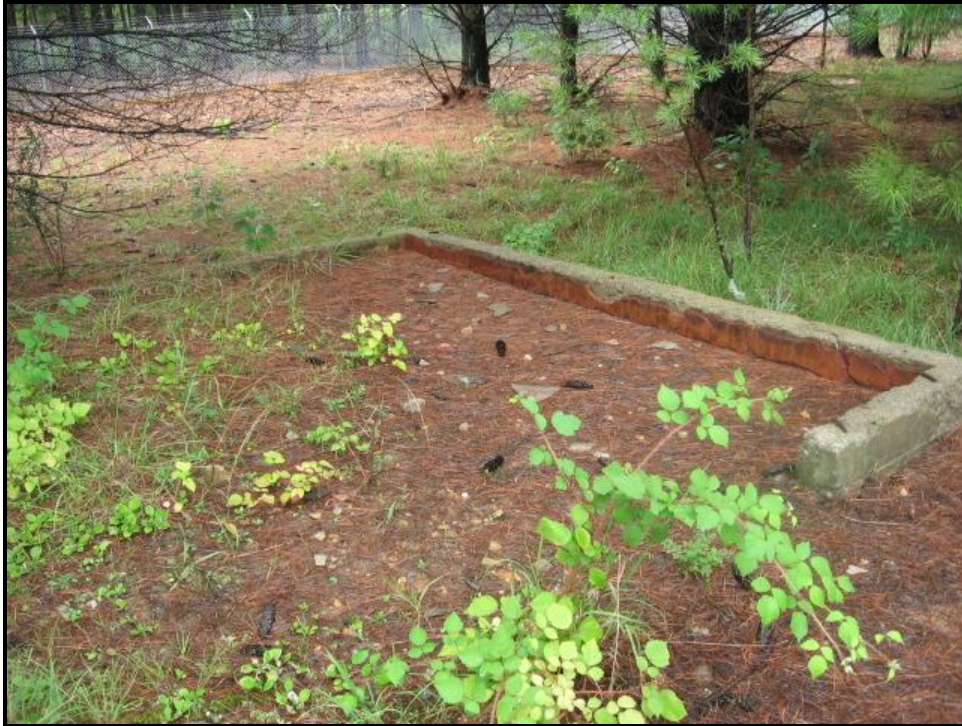
View of IAA Building 1
from August 2008. most
of the conductive flooring
was buried underneath
soil and tree leaves.

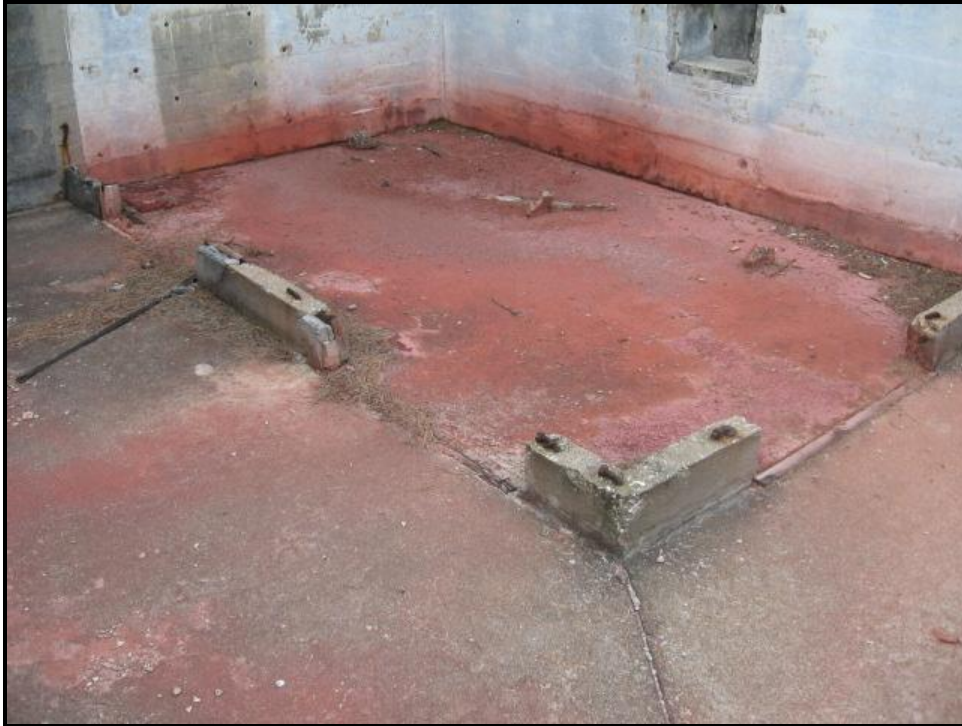
Typical IAA building section prior to conductive flooring removal. January 2011.
