CORRECTIVE ACTION UNIT EVALUATION FOR ASSORTED UNITS (SSA 70, 80, SWMU 61) AT RADFORD ARMY AMMUNITION PLANT

RFAAP, Radford Virginia RCRA Corrective Action Permit Number VA 1210020730

August 2010

CORRECTIVE ACTION UNIT EVALUATION FOR THE HEAVY EQUIPMENT MAINTENANCE SHOP TRACTOR STEAM CLEAN OIL WATER SEPARATOR (SSA 70), THE DRAINAGE DITCH FOR C-LINE WASTEWATER TREATMENT AND PLANT RUNOFF (SSA 80), AND THE MOBILE WASTE OIL TANKS (SWMU 61)

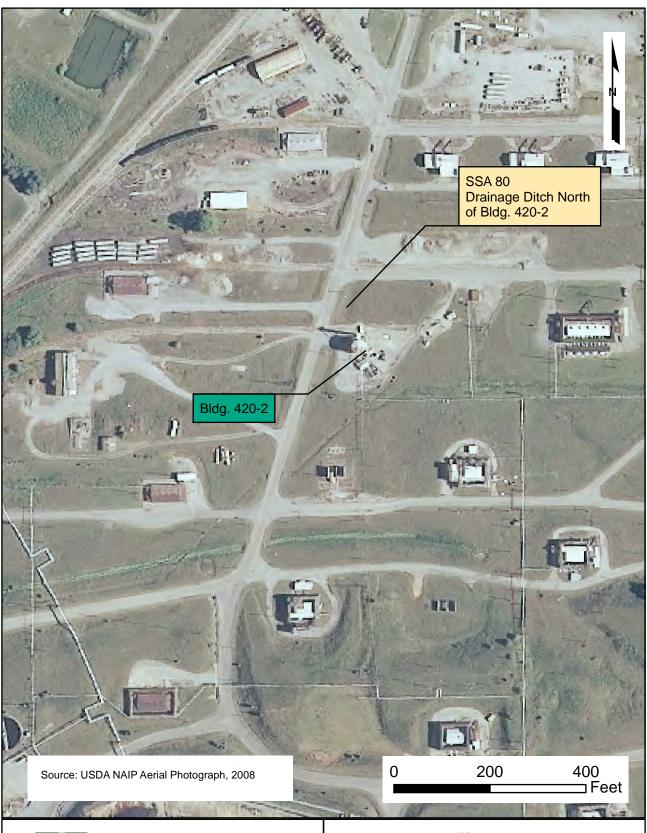
Figure 2 SSA 80 - Drainage Ditch North of Bldg. 420-2

SSA-80 is a grass lined storm water runoff drainage ditch system located immediately adjacent, (north and south), to the C-Line treatment facility, and routinely contains flowing water (**Figure 2**). Storm water runoff collected in the ditches around the C-Line treatment plant flows directly to the New River via Outfall 005, but is not treated at the C-Line treatment plant. Steam condensate from the C-Line facility also drains into the storm water ditch system. The ditch has no record of being contaminated by chemical spills.

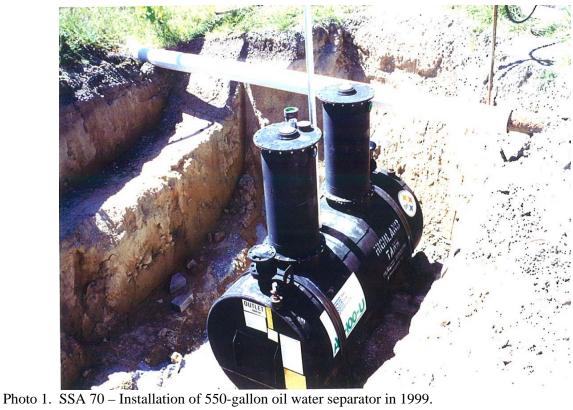
was replaced with clean fill. No volatile organic or semivolatile organic compounds were detected in samples analyzed from the excavated soil (see **Attachment 3**). The oil water separator is constructed of fiberthane coated carbon steel. The unit is in good repair and exhibits no loss of integrity. The integrity of the tank prohibits the infiltration of water contained in the unit to soil and groundwater. (See **Photo Number 1**).

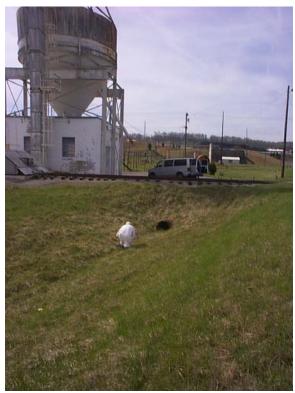
❖ Soil, Groundwater and Surface Water: Laboratory analysis of soil from the ditch (Attachment 3) indicates that soil pH has not increased or decreased in comparison to soil pH from other areas of RFAAP. Given the lack of historical evidence of spills in the area, and the laboratory results, there has been no migration of contaminants to soil, groundwater or surface water at SSA 80. Any stormwater conveyed by the ditch is covered by VPDES permit at Outfall 005. (See Photo Number 2).

Photo 2. SSA 80 – C-line ditch. Bldg. 420-2 is located in the background.
