Final
First Five-Year Review Report for

RADFORD ARMY AMMUNITION PLANT
NEW RIVER UNIT (RAAP-044)
RADFORD, VIRGINIA
USEPA ID VA1210020730

May 2018

Prepared By:
U.S. Army Corps of Engineers
Buffalo District
1776 Niagara Street
Buffalo, New York 14207

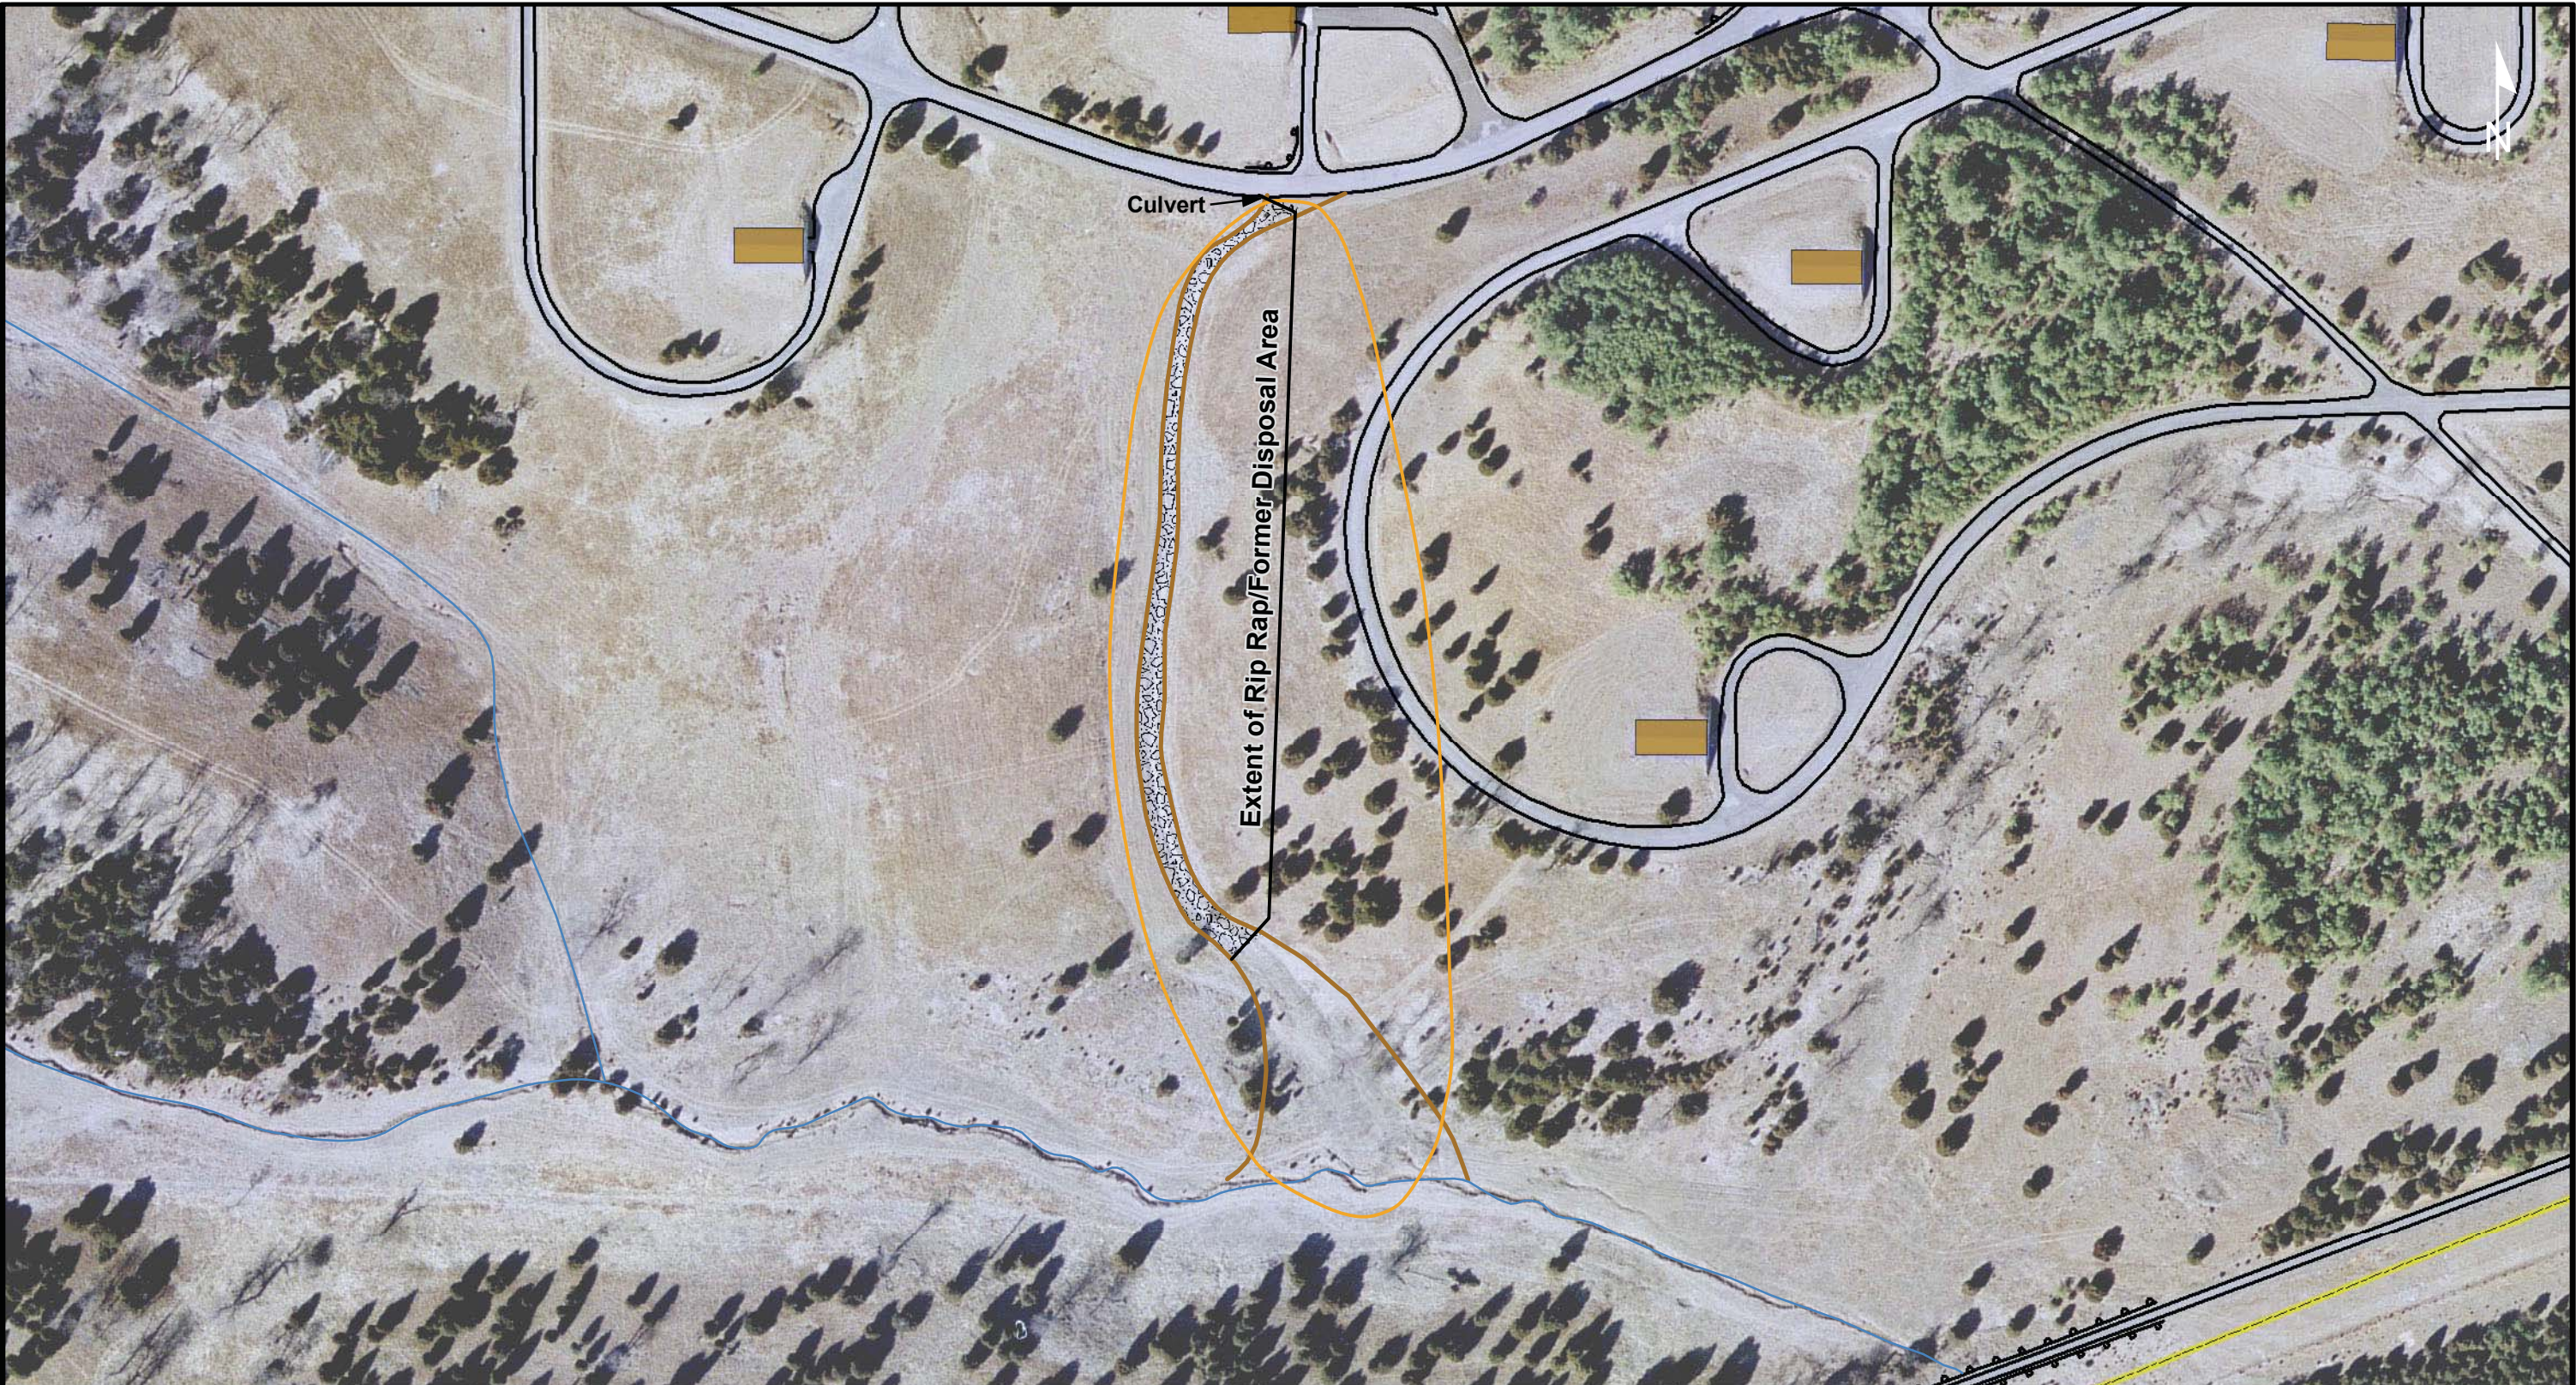
FIGURE
2

This five-year review of the Radford Army Ammunition Plant (RFAAP) New River Unit (NRU) (RAAP-044) was conducted by the United States Army Corps of Engineers (USACE) Buffalo District on behalf of the United States Army Environmental Command (USAEC). RFAAP is an active government-owned, contractor operated facility located in Radford, Virginia (Figure 1 in Attachment 1). The remedial activities in the NRU subject to this review are located in three distinct areas (Figure 2 in Attachment 1):

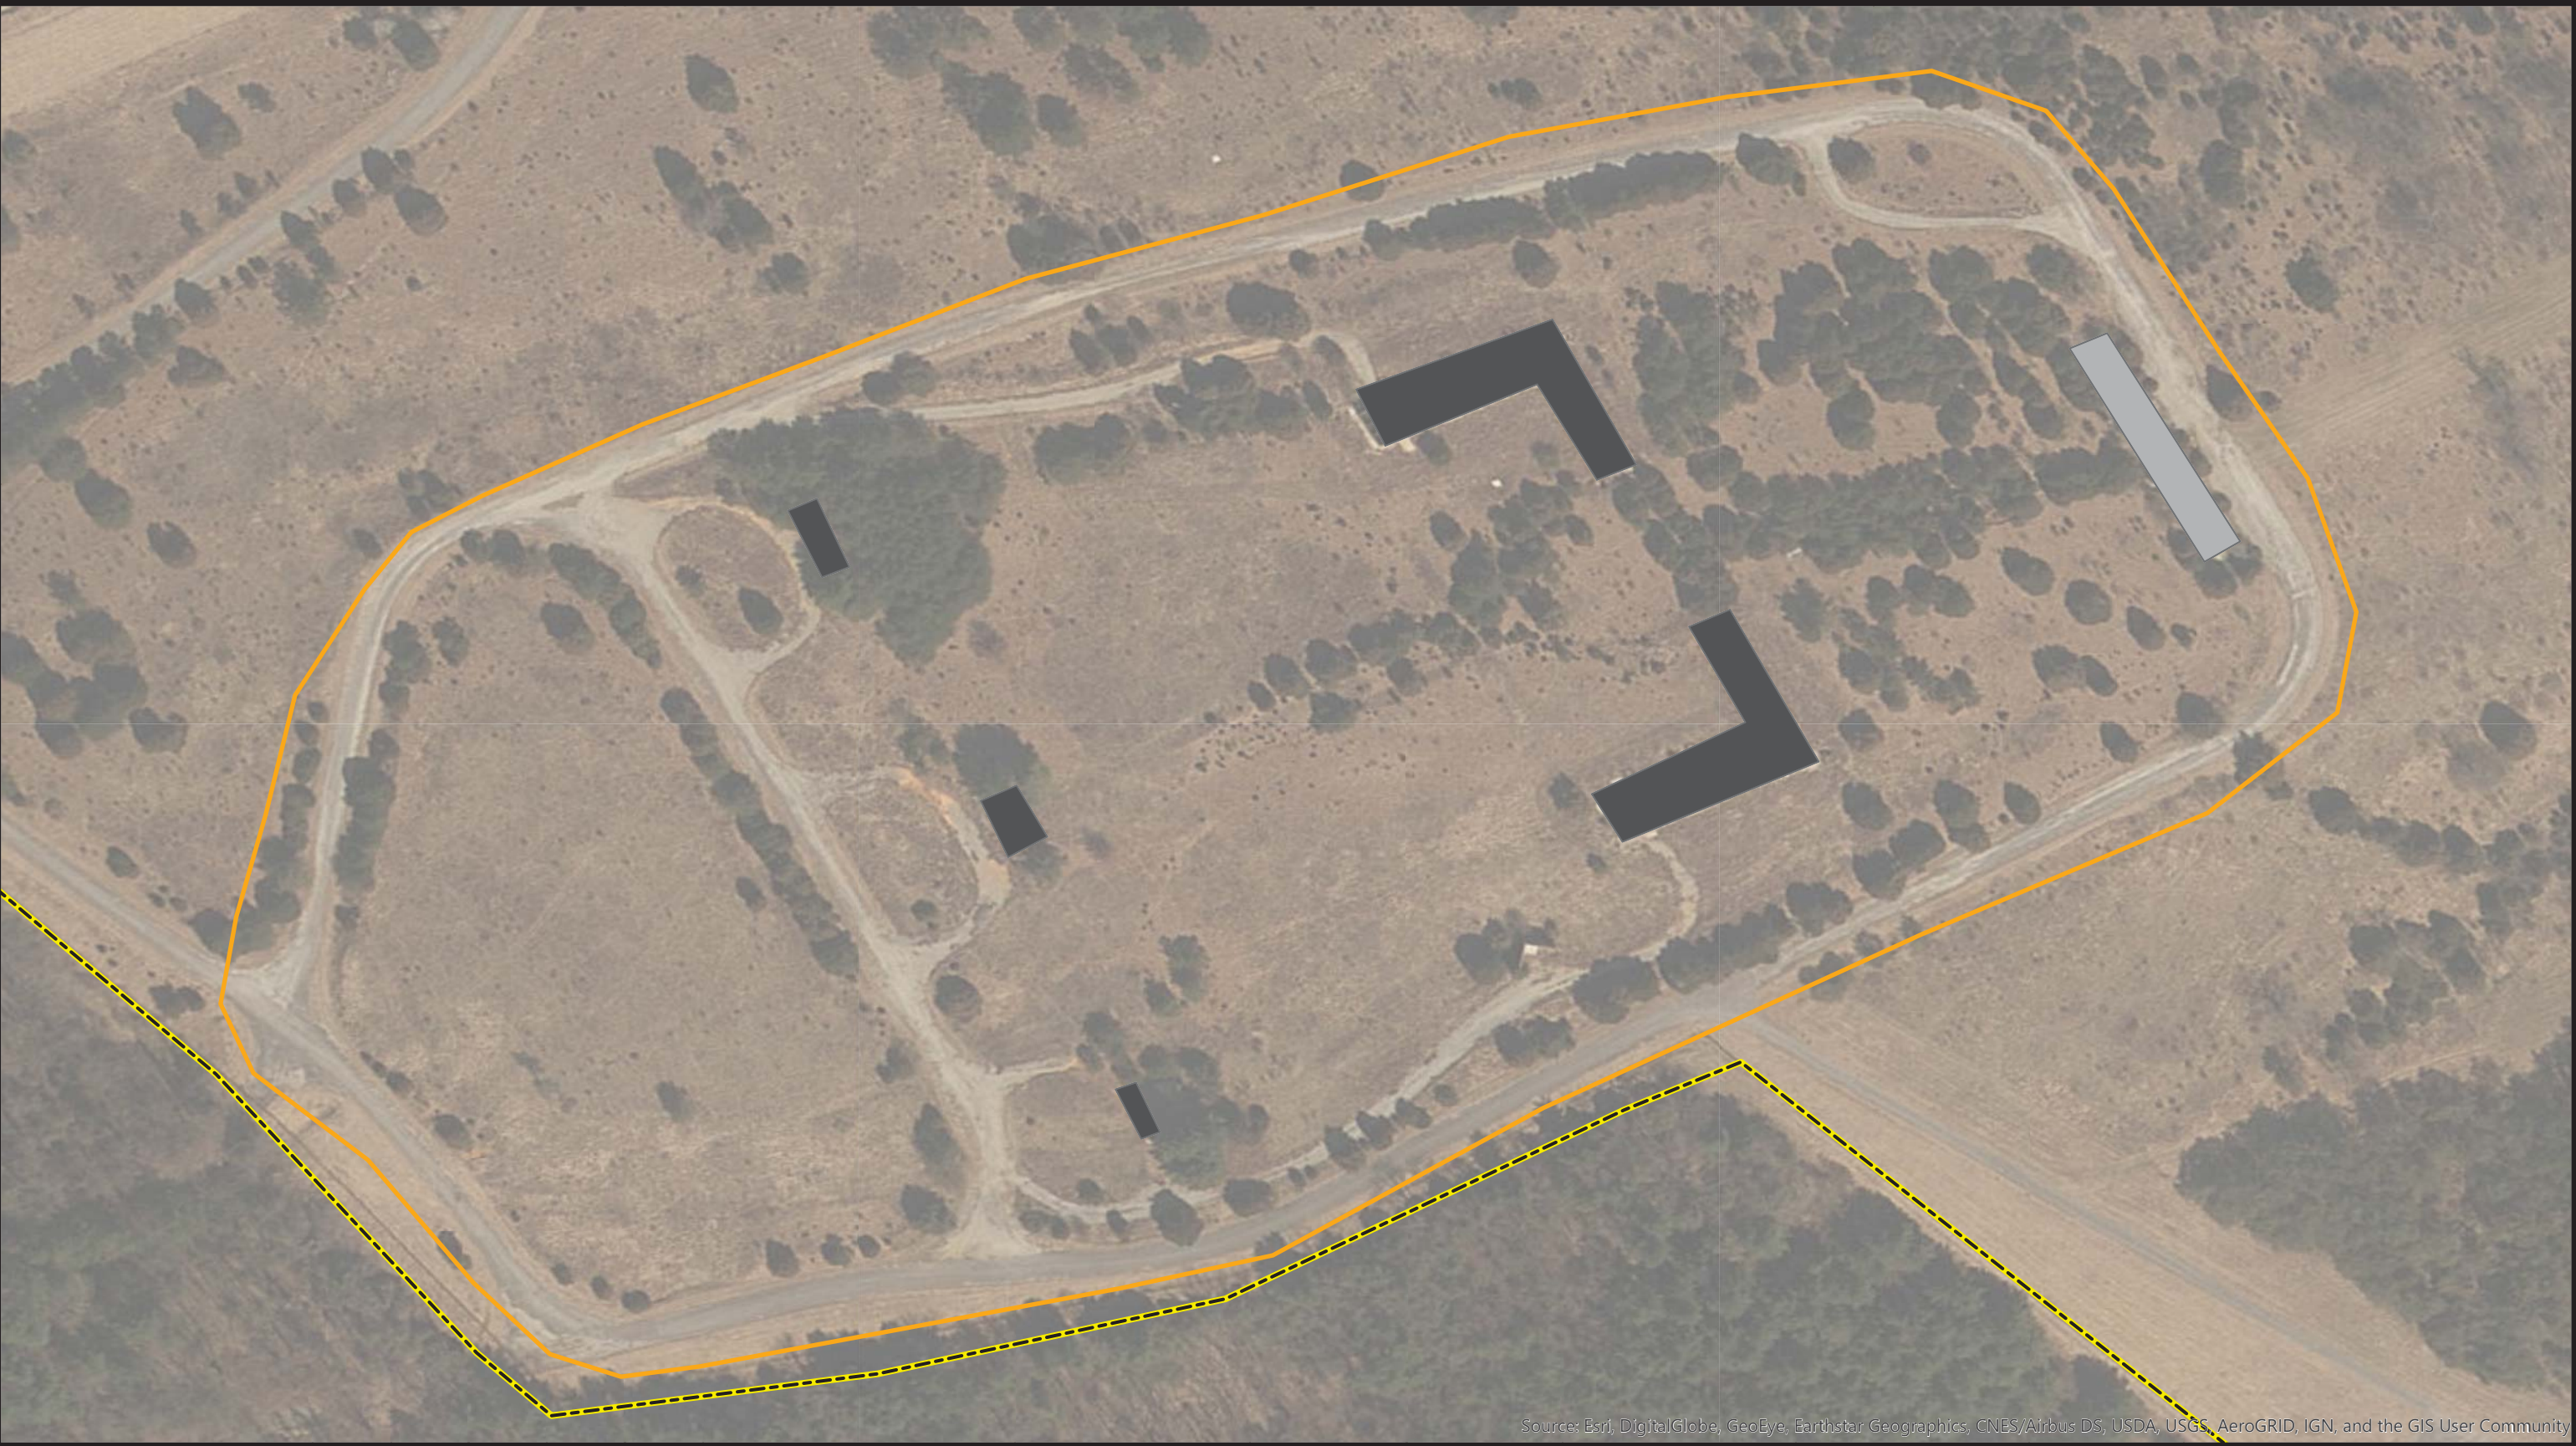
**FIGURE
3**

The BDDT encompasses approximately 5 acres near the southern boundary of the NRU and consists of rolling grass-covered hills (Figure 3 in Attachment 1). The BDDT includes what was formerly a natural drainage channel that had eroded into the clay soils between the two hills. This drainage channel directs surface water runoff from the surrounding area toward a small unnamed stream that runs through the southwestern portion of the NRU. The BDDT was historically used for disposal activities.

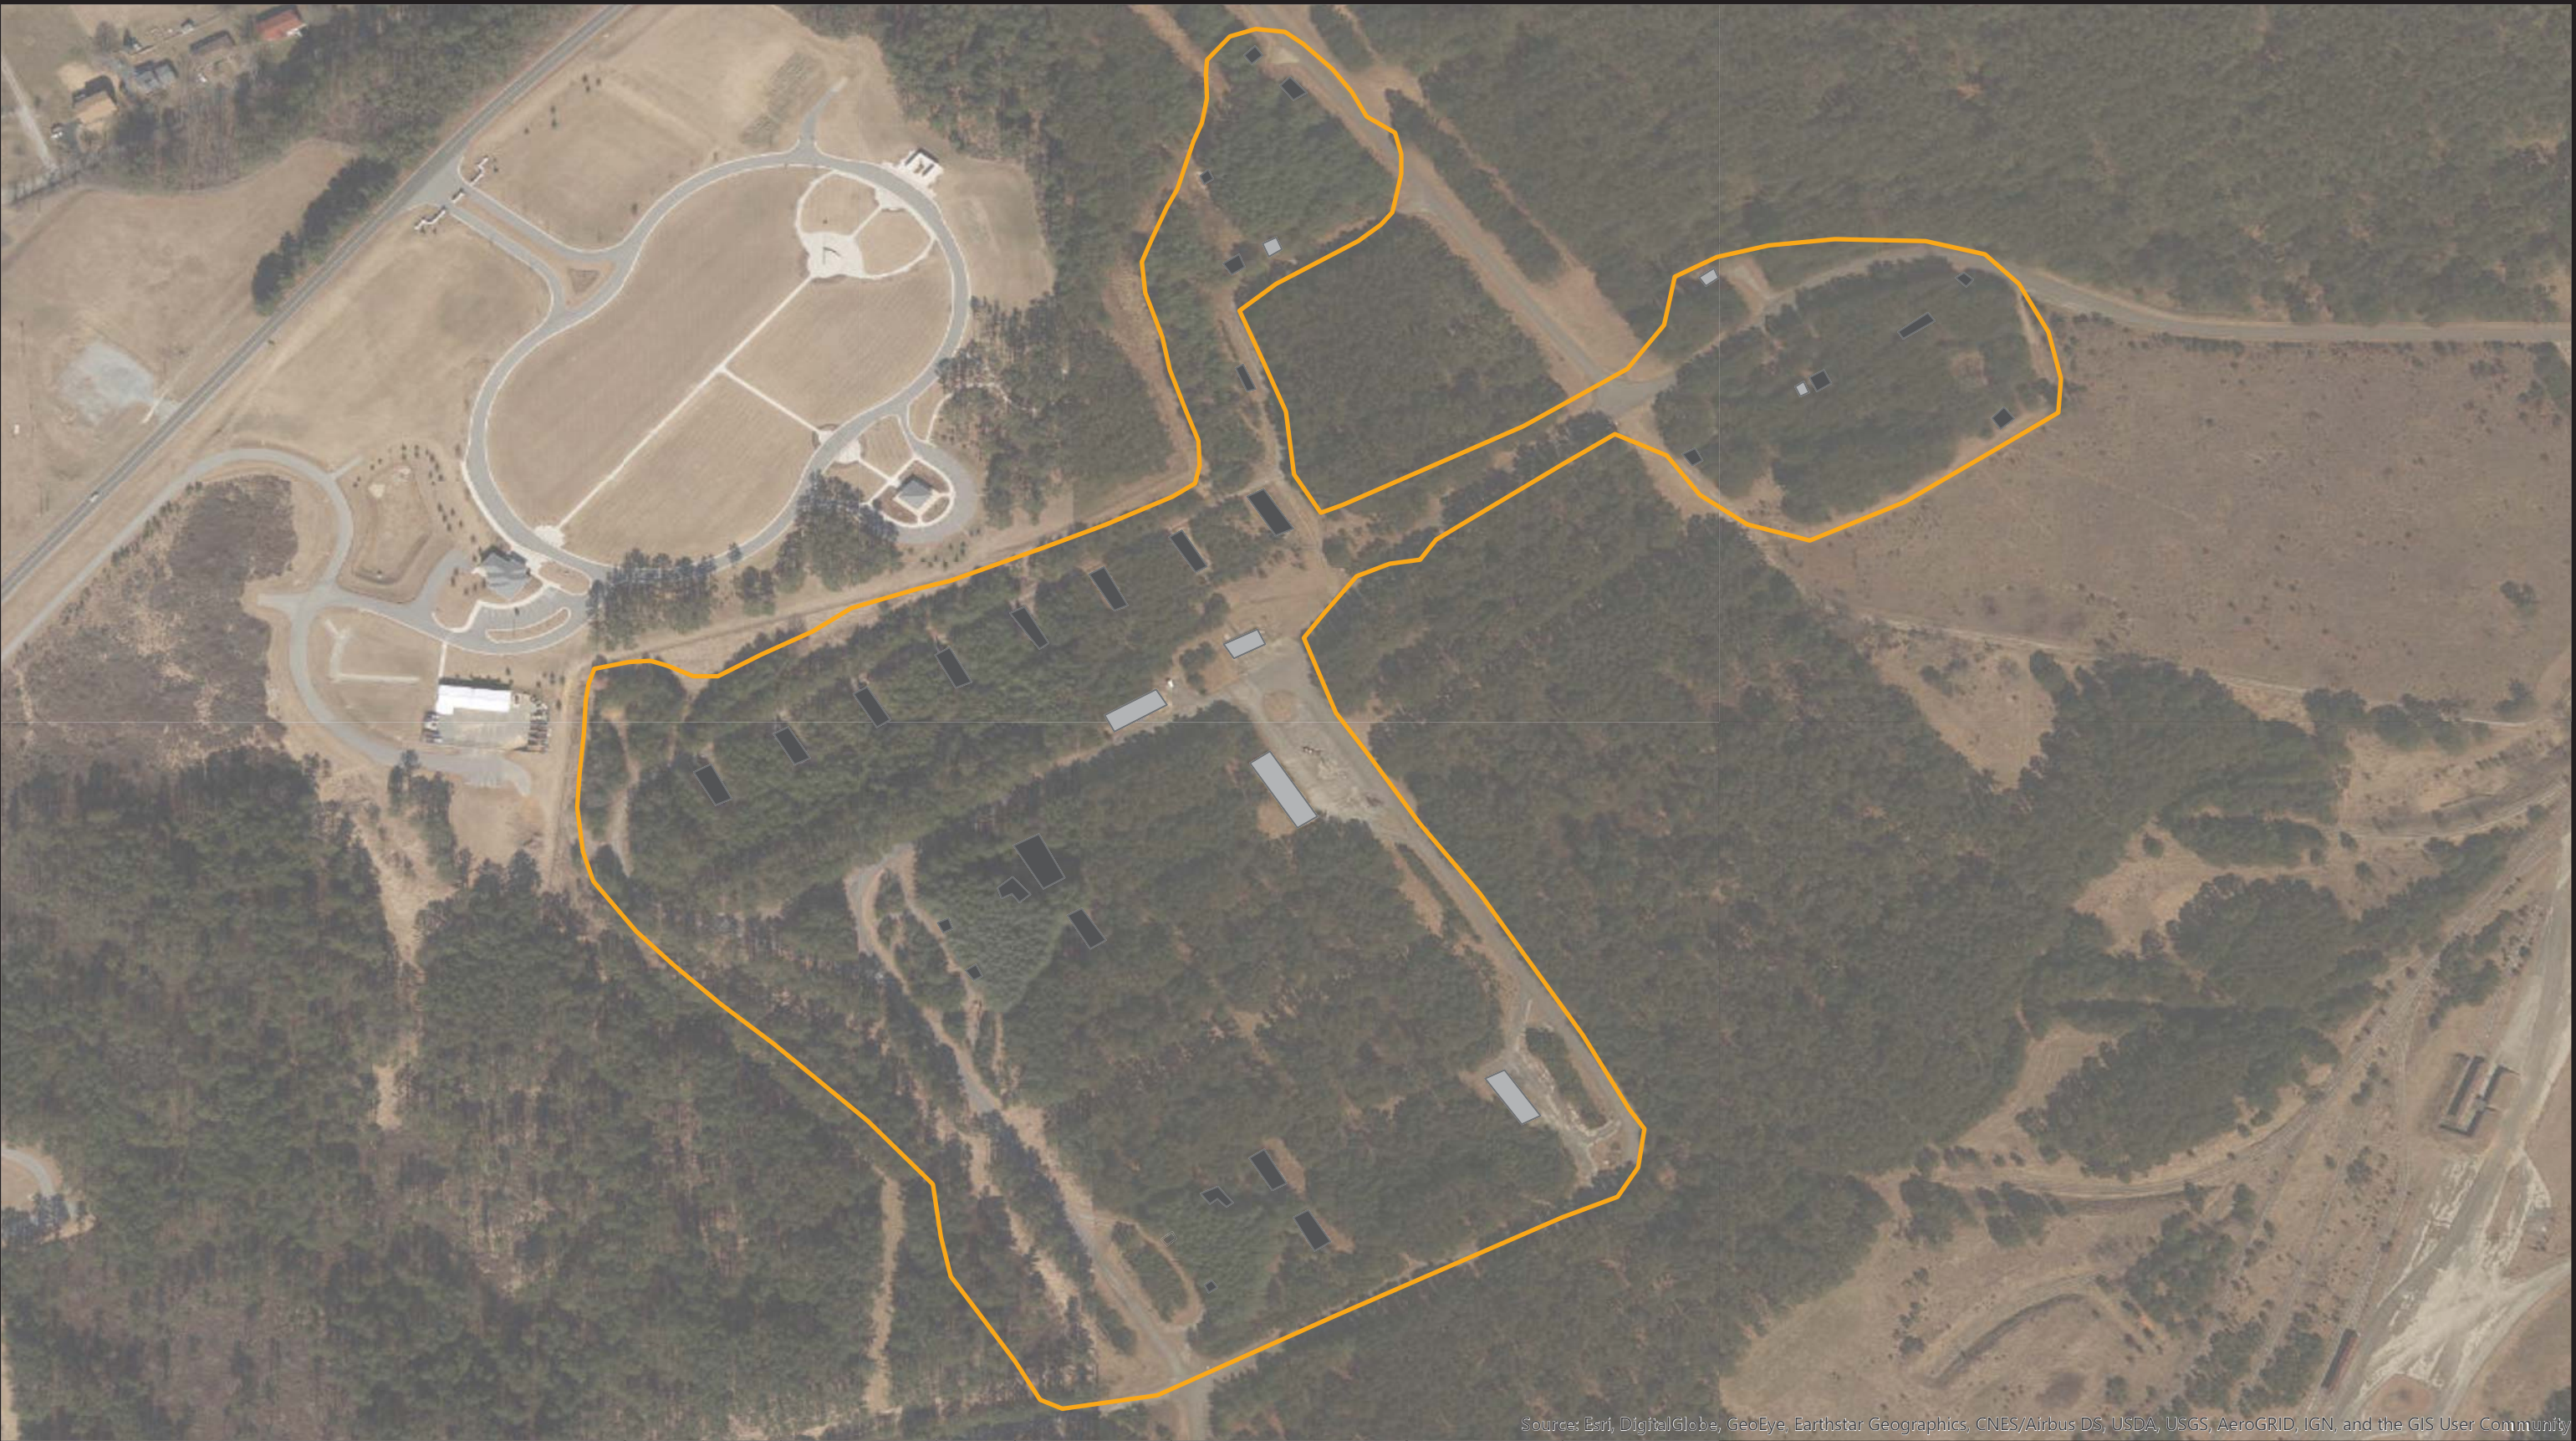
Figure 4

The BLA is located on a hilltop along the southwestern boundary of the NRU (Figure 4 in Attachment 1). A total of ten buildings were formerly located at the BLA. An unnamed stream is located north of the BLA.

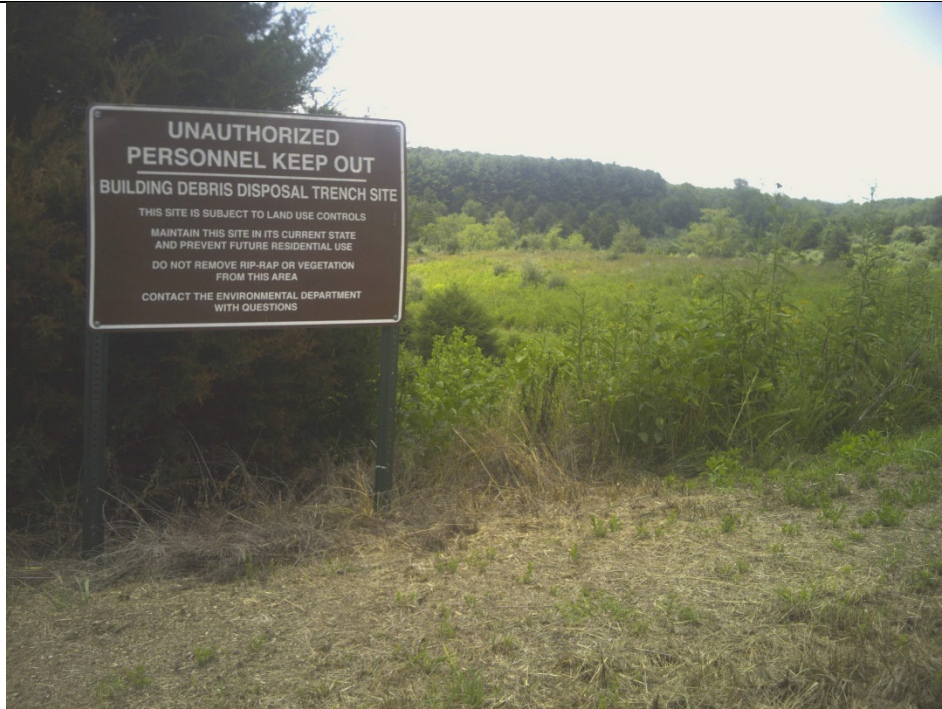
Photo No. 1
(31-July-2017)

Description:
Signage at the
BDDT
describing
LUCs and
access
restrictions.

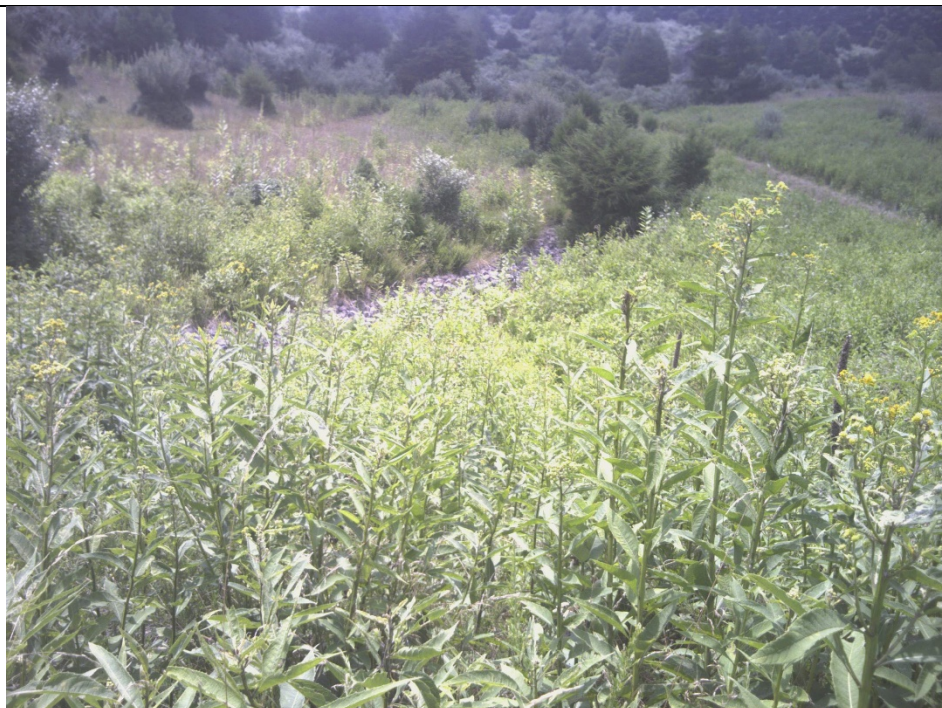
Photo No. 2
(31-July-2017)

- LUC signage was present in the vicinity of the BDDT
- The rip rap liner and downgradient vegetation at the BDDT was observed to be in good condition
- No changes in site use or evidence of intrusive activities were observed at the BDDT
- Access to the NRU was restricted by a perimeter fence with security personnel at the access gate and on roving patrols. The fence was observed to be in good condition.

Description:
View of
vegetation and
rip-rap at the
BDDT
included in the
remedy to
prevent
erosion.

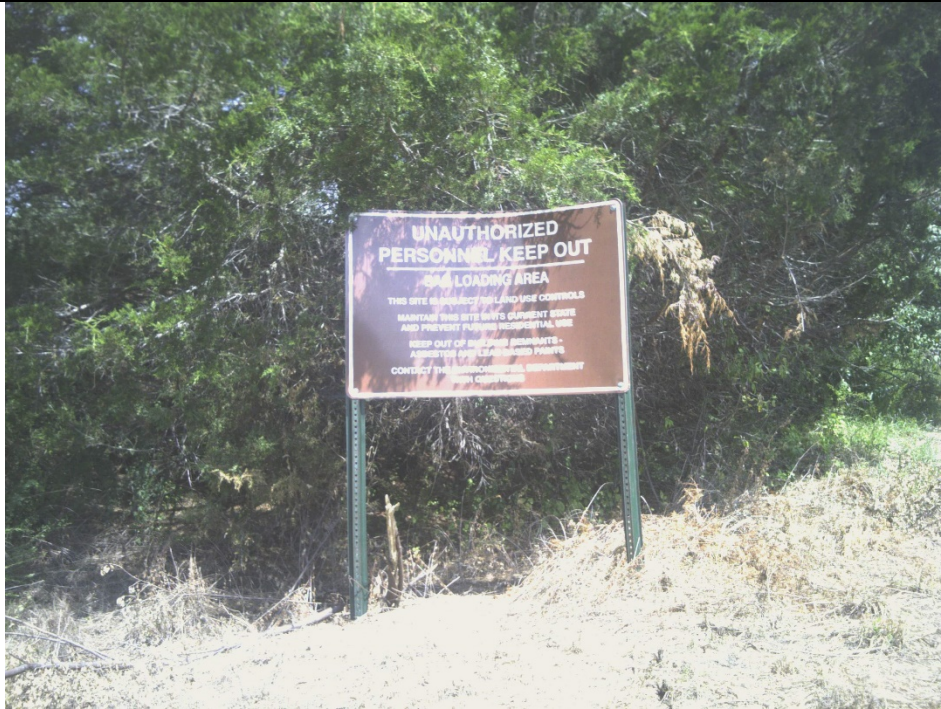
Photo No. 3
(31-July-2017)

Description:
Sign at the
northwest
entrance to the
BLA
describing
LUCs.

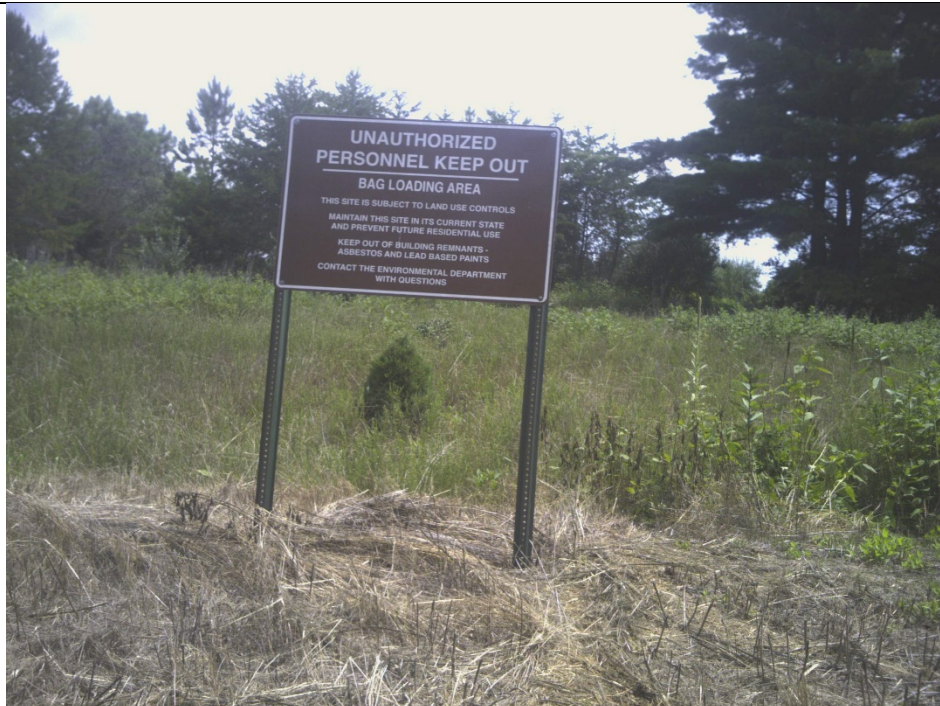
Photo No. 4
(31-July-2017)

Description:
Second LUC
sign at the
BLA at the
southwestern
edge of the
site.

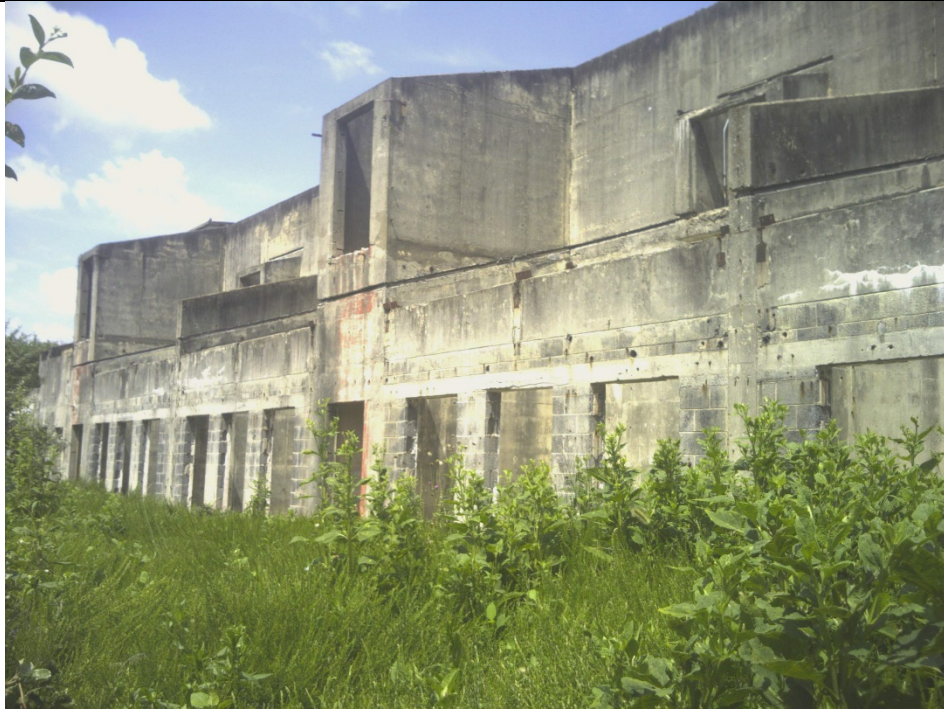
Photo No. 5
(31-July-2017)

Description:
Building remnants at the BLA. Conductive flooring was removed in 2010. Lead based paint and asbestos contamination are present on-site.

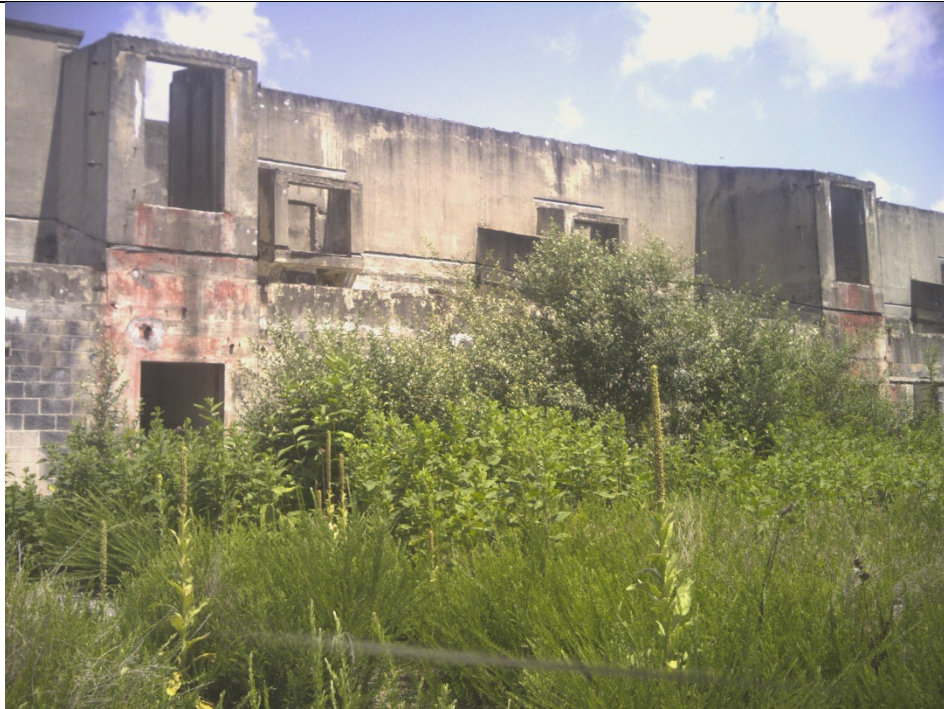
Photo No. 6
(31-July-2017)

Description:
View of remnants of building at the BLA. Red staining on the concrete is from the conductive flooring that was removed in 2011.

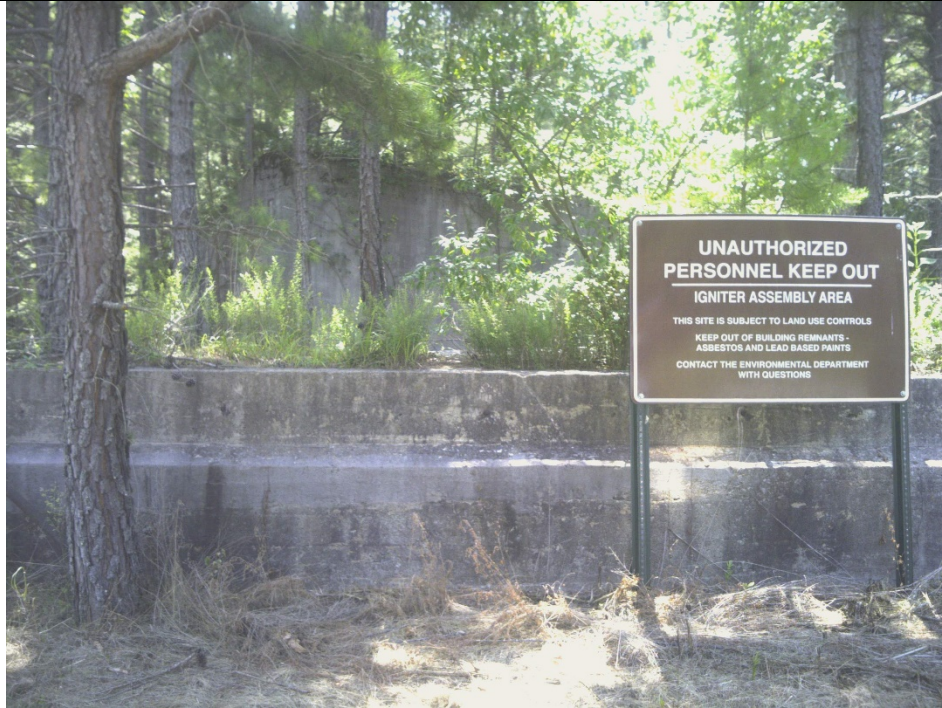
Photo No. 7
(31-July-2017)

Description:
LUC signage
at the IAA
with concrete
remnants of
former
building in
background.

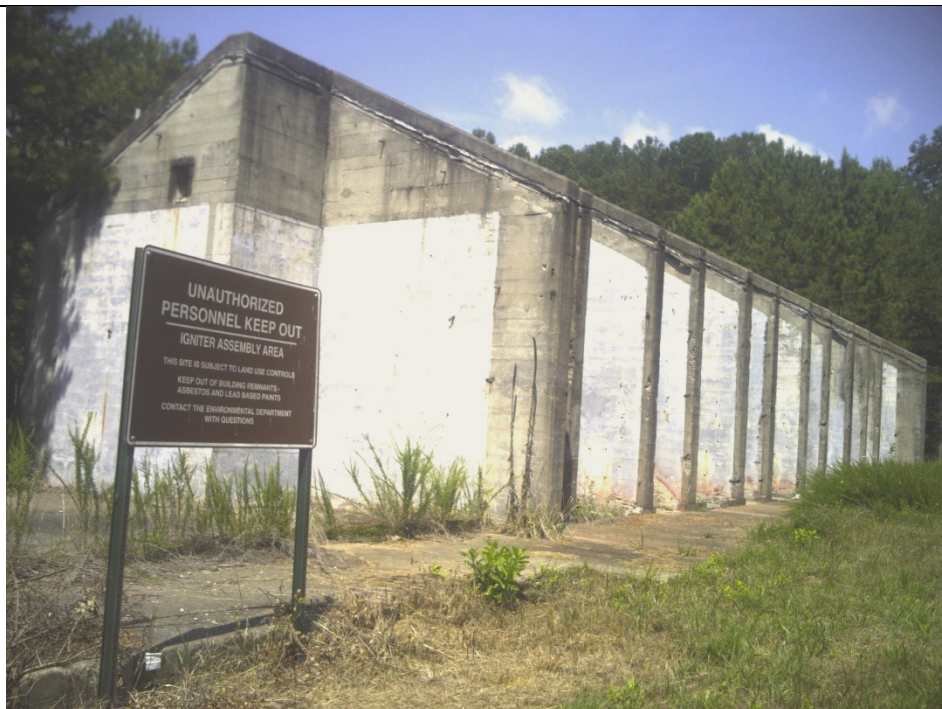
Photo No. 8
(31-July-2017)

Description:
Additional
LUC signage
at the IAA in
front of
building
remnants
where
conductive
flooring was
removed.
Remnants are
contaminated
with asbestos
and lead based
paints.

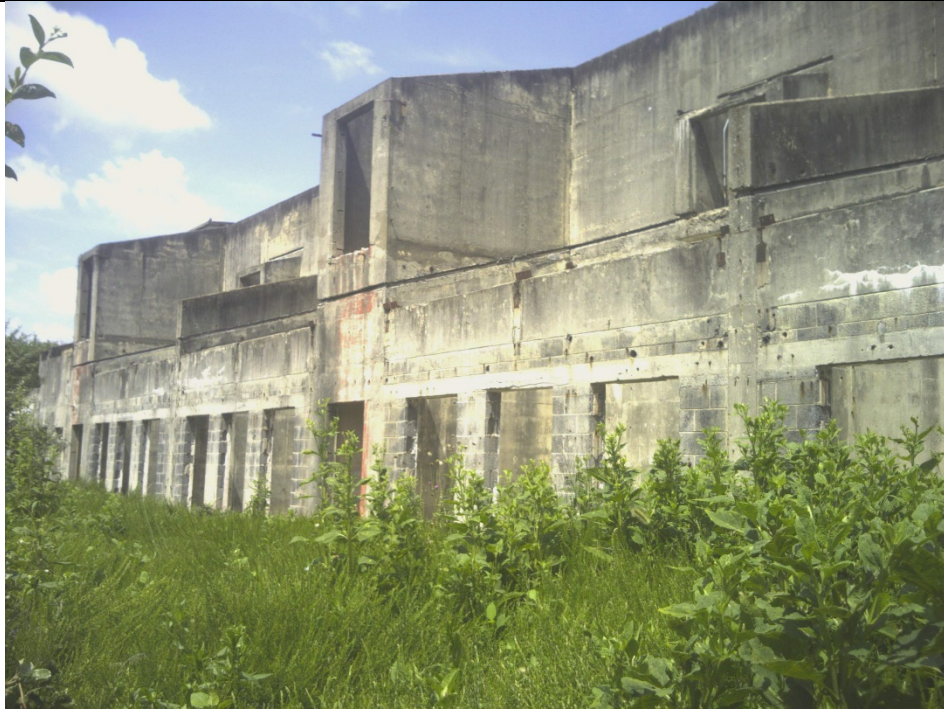
Photo No. 5
(31-July-2017)

Description:
Building remnants at the BLA. Conductive flooring was removed in 2010. Lead based paint and asbestos contamination are present on-site.

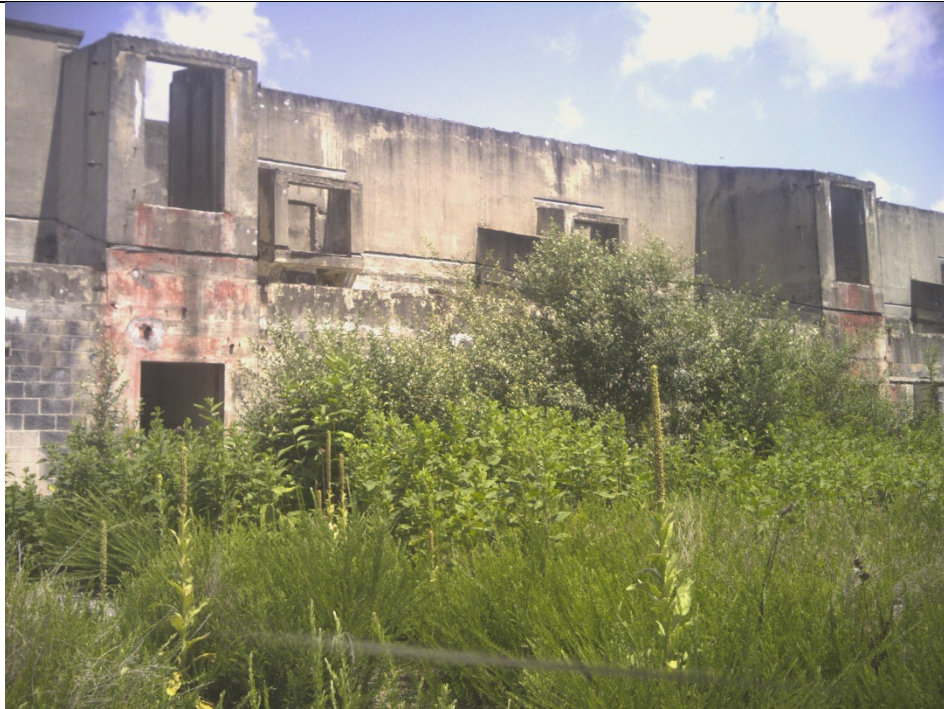
Photo No. 6
(31-July-2017)

Description:
View of remnants of building at the BLA. Red staining on the concrete is from the conductive flooring that was removed in 2011.

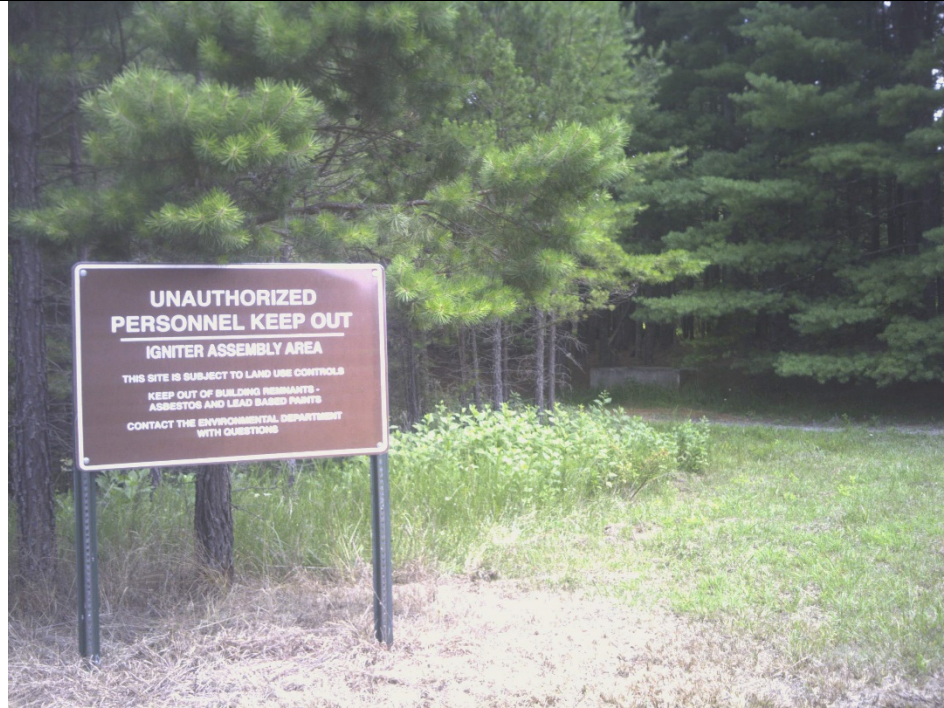
Photo No. 9
(31-July-2017)

Description:
Third LUC
sign
southwestern
corner of the
IAA.
