Radford Army Ammunition Plant

MAIN MANUFACTURING AREA

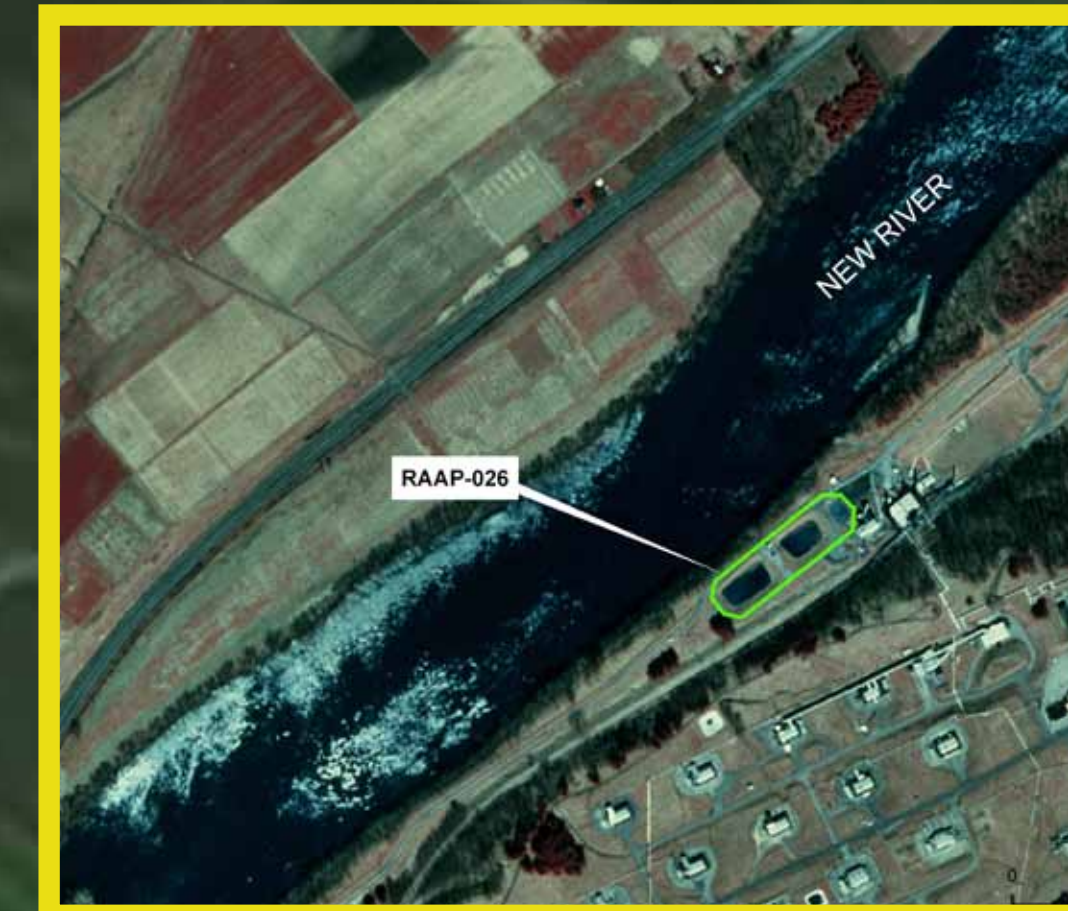
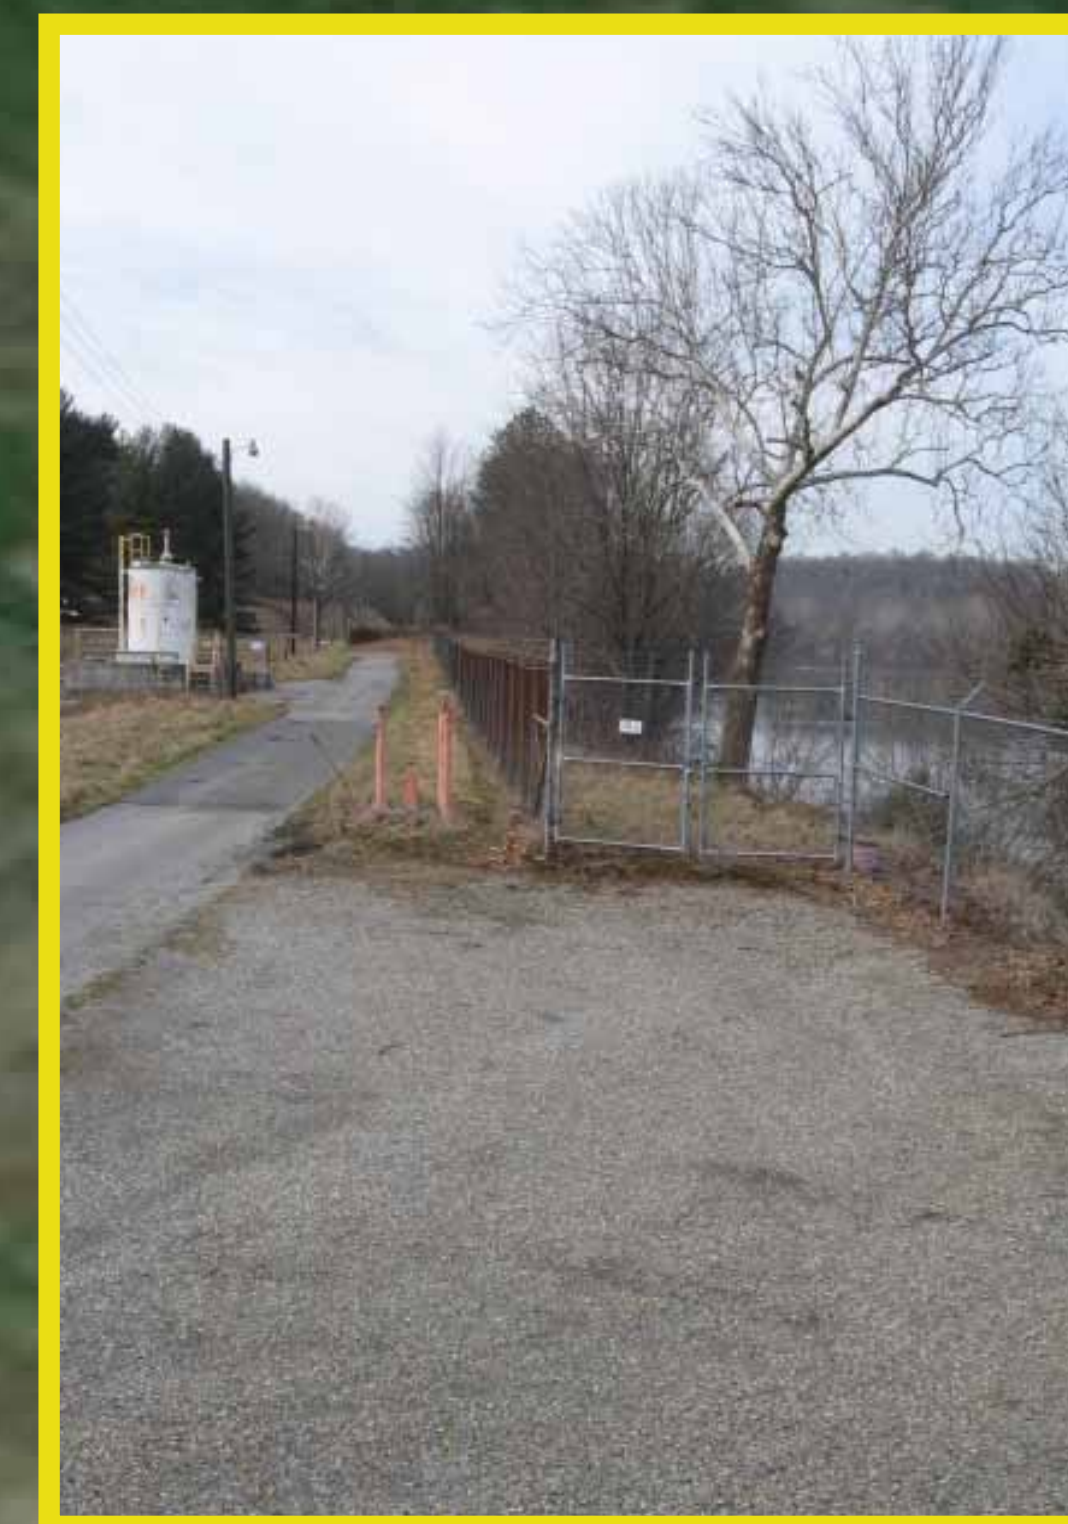
SWMU-31

History

- Comprised of three lagoons that served the potable Water Treatment Plant (WTP) and Power House No 2 since the 1950s
- Power House No. 2 discharged ceased in 1980s
- Received water carrying fly and bottom ash
- Currently receives filter water backwash from WTP

(RAAP-026)
Coal Ash Settling Lagoons

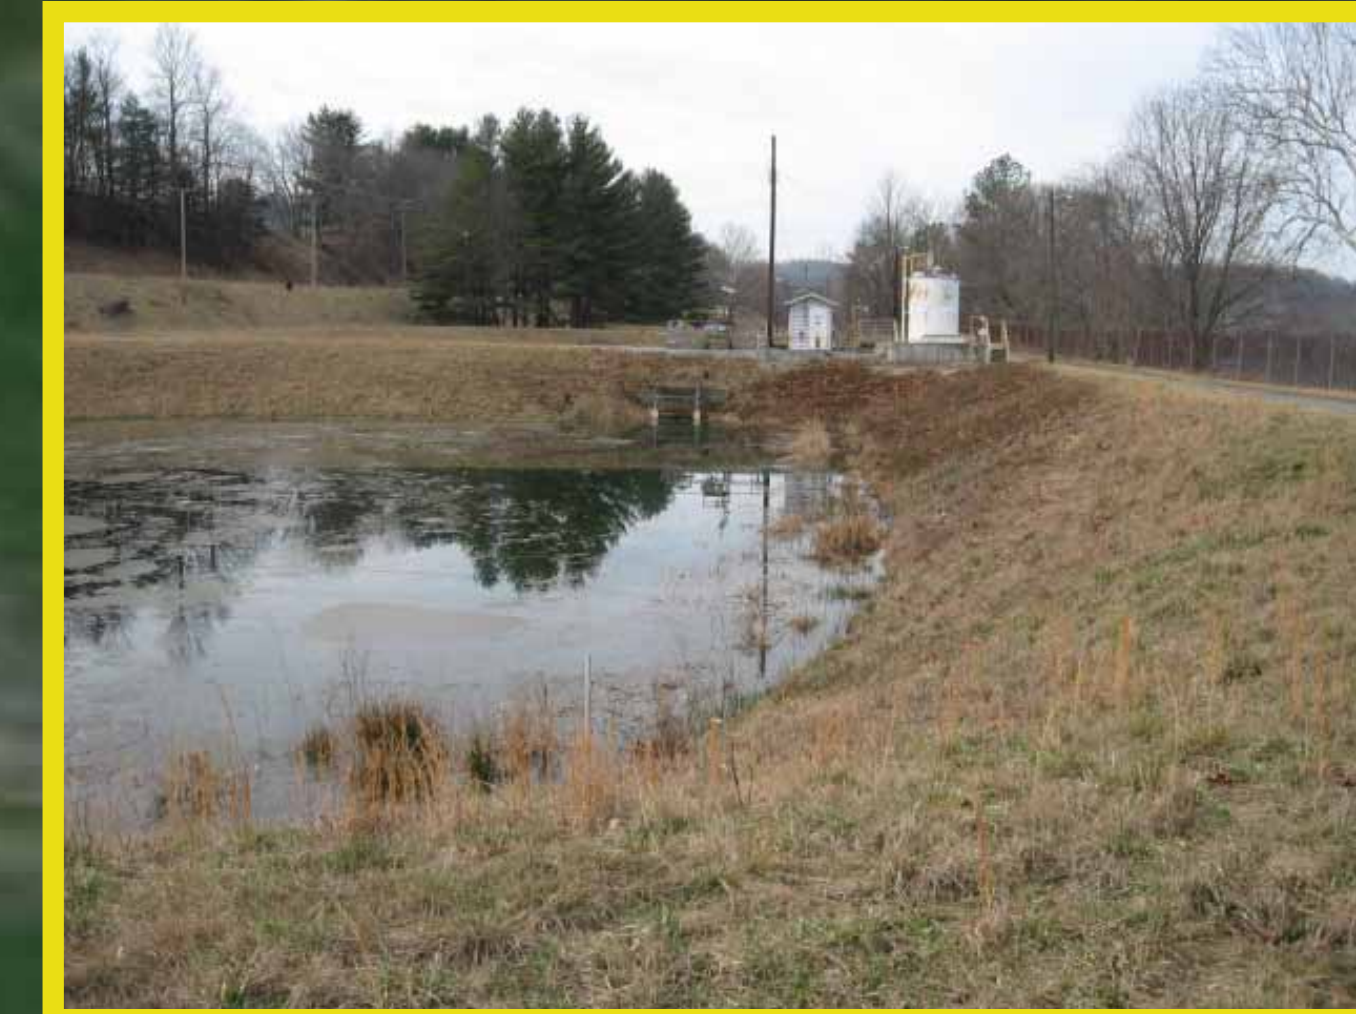
Findings

- Potential risks to human health under current land use (military / industrial) are within the USEPA generally acceptable risk range
- Low potential for ecological impacts associated with surface water and sediment in primary lagoon; however, risk is minimized due to small area that is affected (~0.11 acres)
- Ecological risk drivers in sediment were very low levels of dioxin and DDT
- Ecological risk drivers in surface water were aluminum, barium, iron, lead, endosulfan II, endrin and pyrene
- Concentrations of constituents in soil are within background levels or less than residential screening levels
- Concentrations of compounds detected in groundwater are less than MCLs or within background levels
- Data Gap groundwater sampling confirmed that benzo(a)pyrene is not present in groundwater

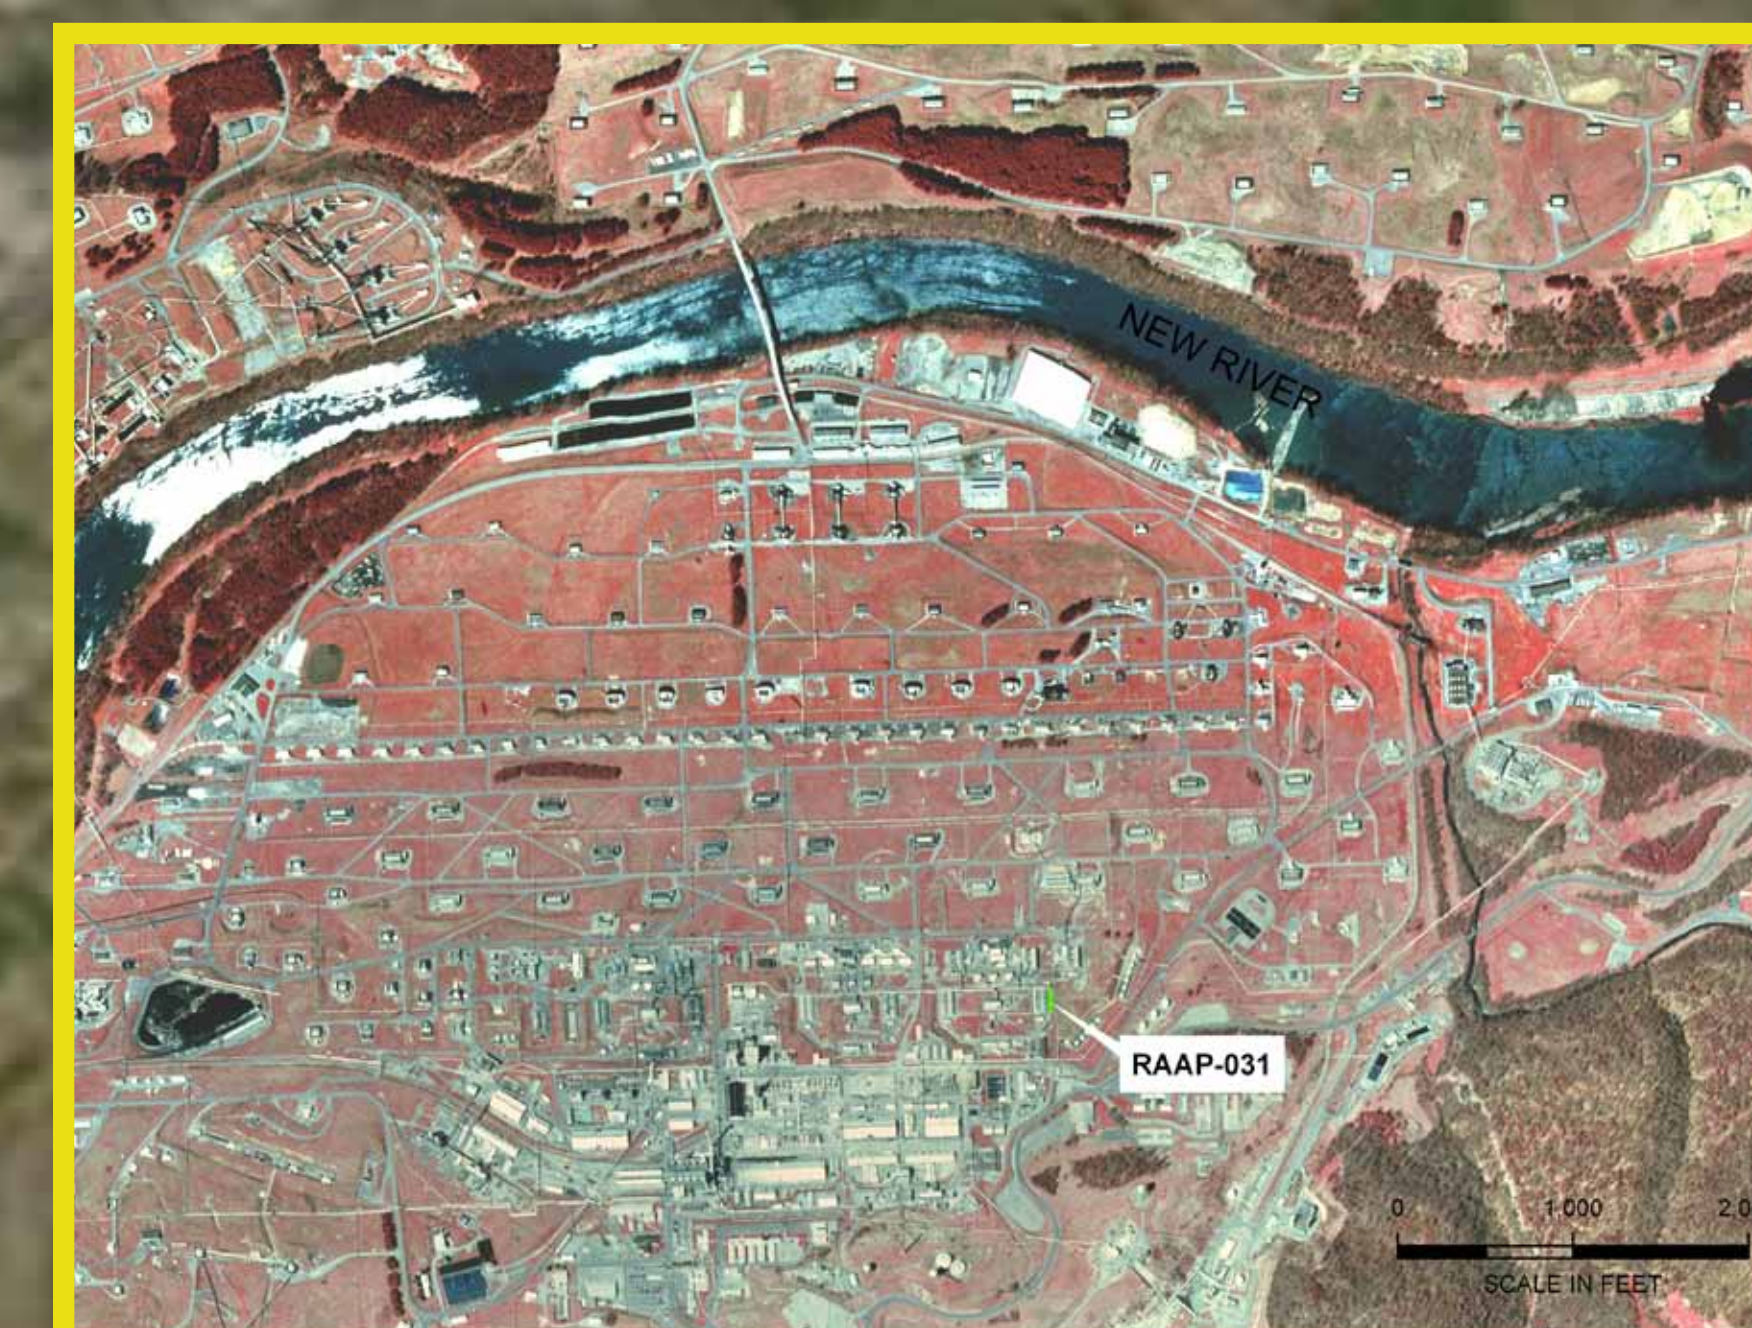
AOC A

(RAAP-031)
Nitrocellulose Rainwater Ditch

Findings

- Site Screening Process identified dinitrotoluene and PCBs in soil greater than screening levels
- RCRA Facility Investigation (RFI) was conducted in 2008 to delineate dinitrotoluene and PCBs in soil
- Dinitrotoluene and PCBs are limited to surface soil in small area, capped by a concrete stormwater conveyance
- Potential risks to human health under current (military/ industrial) and future (hypothetical residential) are within the USEPA generally acceptable risk range
- Final RFI report recommending No Further Action was submitted in September 2009 and approved by VDEQ and USEPA in October 2009
