Radford Army Ammunition Plant

MAIN MANUFACTURING AREA

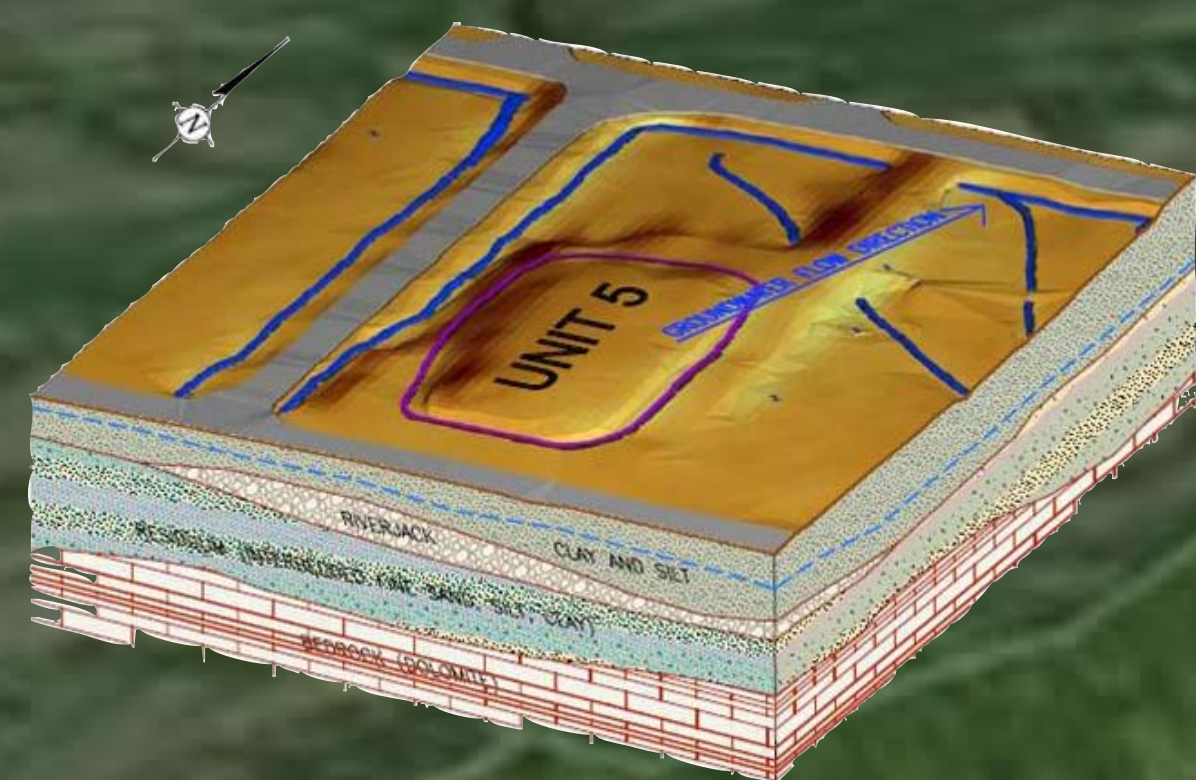
HWMU-5

- Put into operation as an unlined impoundment in 1970
- Primarily used as an acid neutralization pond. Also received storm water and process wastewater.
- Liner placed in 1981
- Operation ceased in 1986
- Capped in 1989

- Limestone/dolomite bedrock covered by weathered and alluvial deposits
- Ground occurs in the unconsolidated material at approximately 15 to 20 ft bgs
- Groundwater generally flows to the northeast

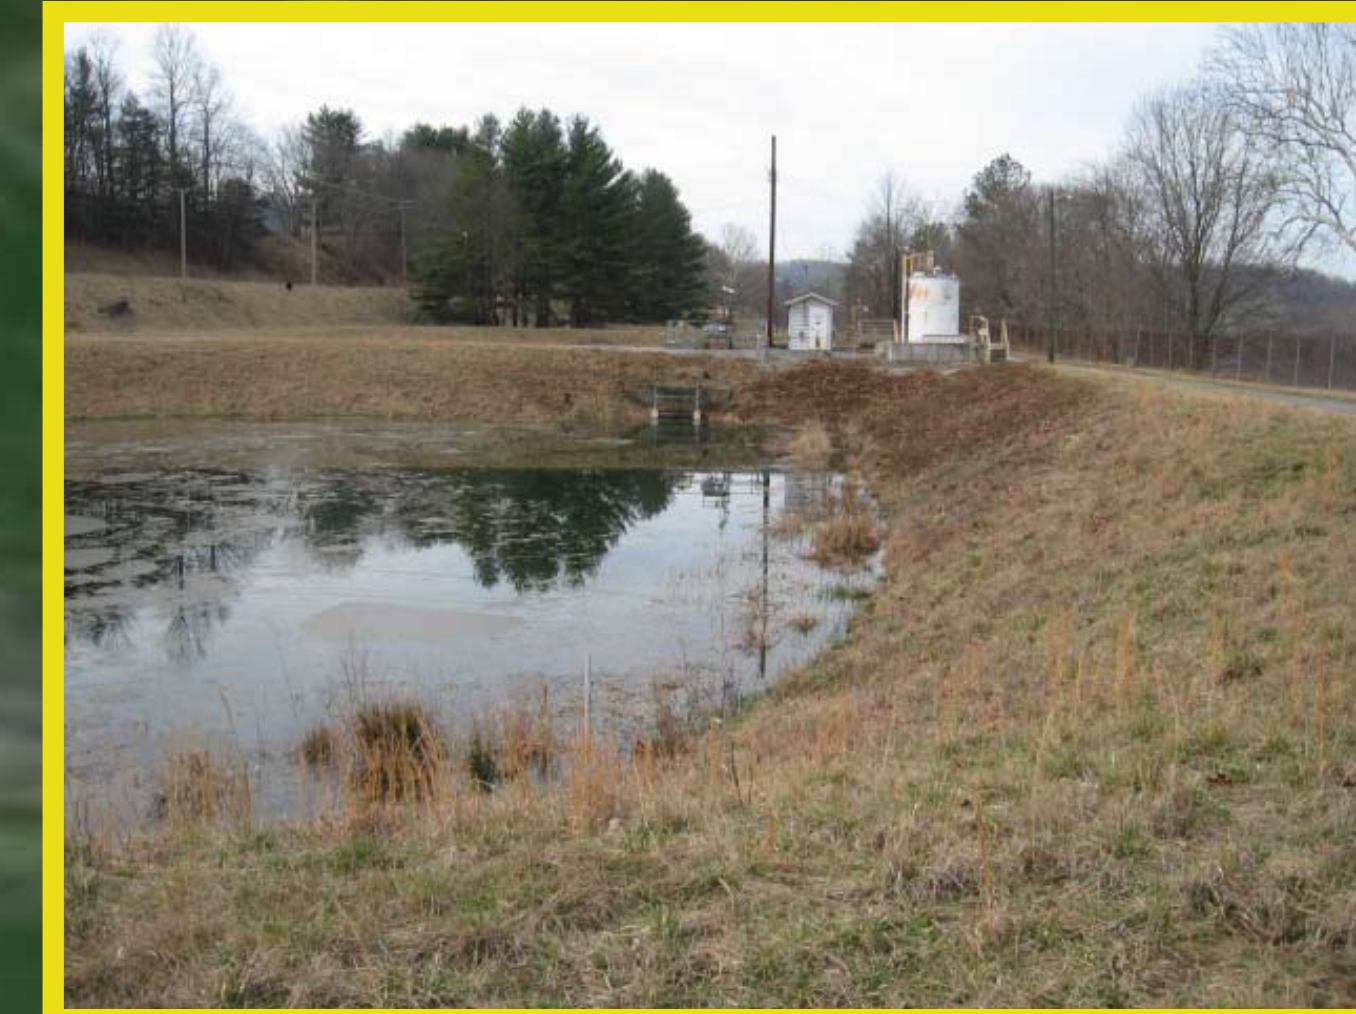
SWMU-31

- Comprised of three lagoons that served the potable Water Treatment Plant (WTP) and Power House No 2 since the 1950s
- Power House No. 2 discharged ceased in 1980s
- Received water carrying fly and bottom ash
- Currently receives filter water backwash from WTP

(RAAP-026)
Coal Ash Settling Lagoons

- Potential risks to human health under current land use (commercial/industrial) are within or less than USEPA target risk range.
- Low potential for ecological impacts associated with surface water and sediment in primary lagoon; however, risk is minimized due to small area that is affected (~0.11 acres)
- Ecological risk drivers in sediment were very low levels of dioxin and DDT
- Ecological risk drivers in surface water were aluminum, barium, iron, lead, endosulfan II, endrin and pyrene
- Concentrations of constituents in soil are within background levels or less than residential screening levels
- Concentrations of compounds detected in groundwater are less than MCLs or within background levels
- Data Gap groundwater sampling confirmed that benzo(a)pyrene is not present in groundwater

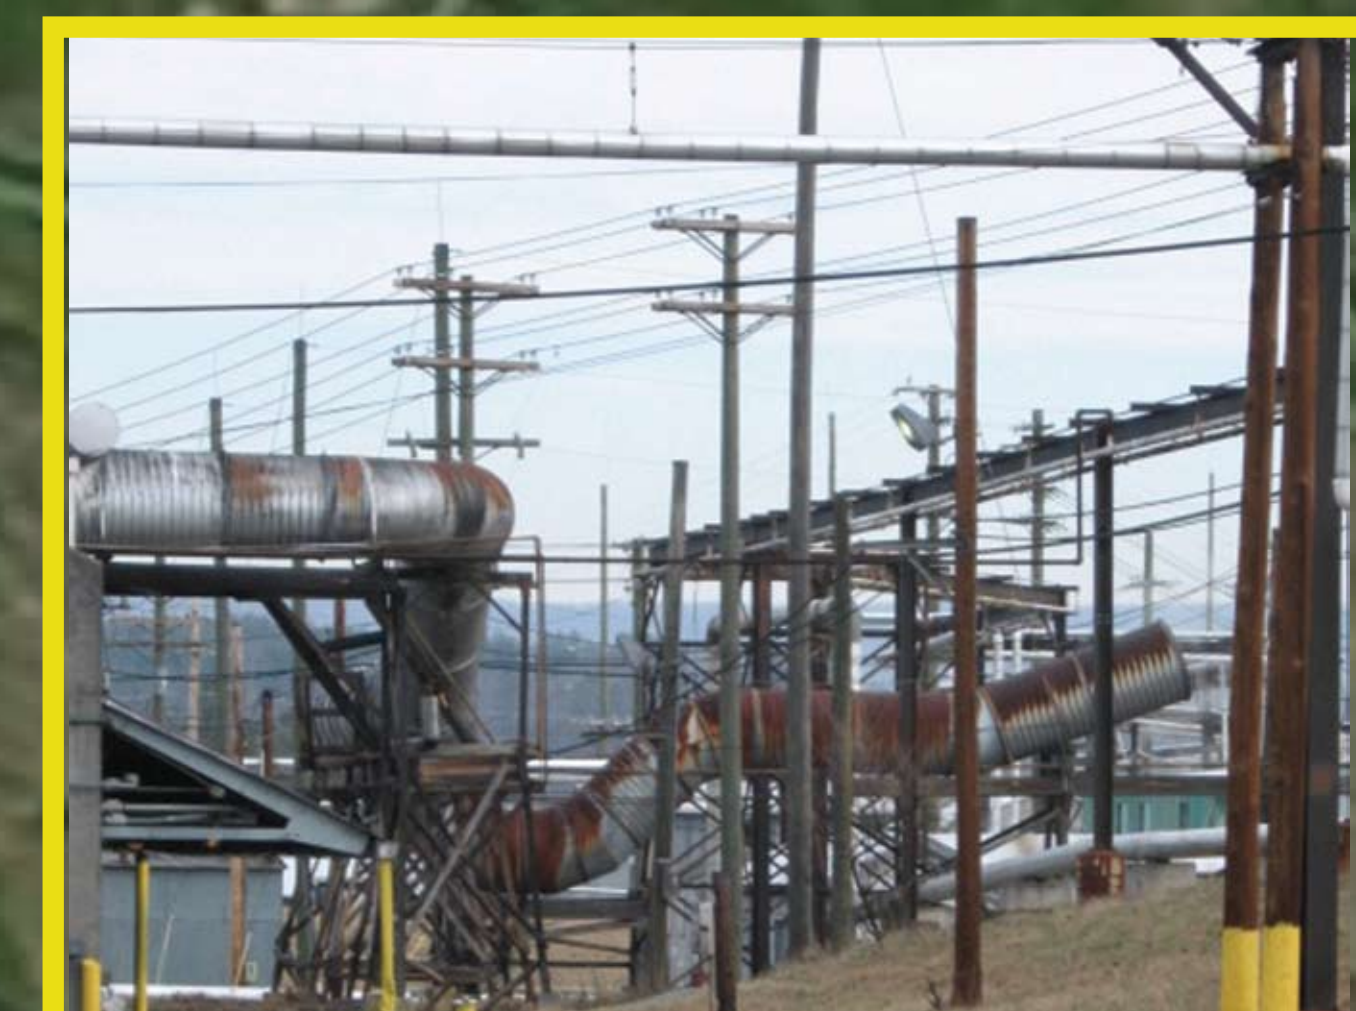
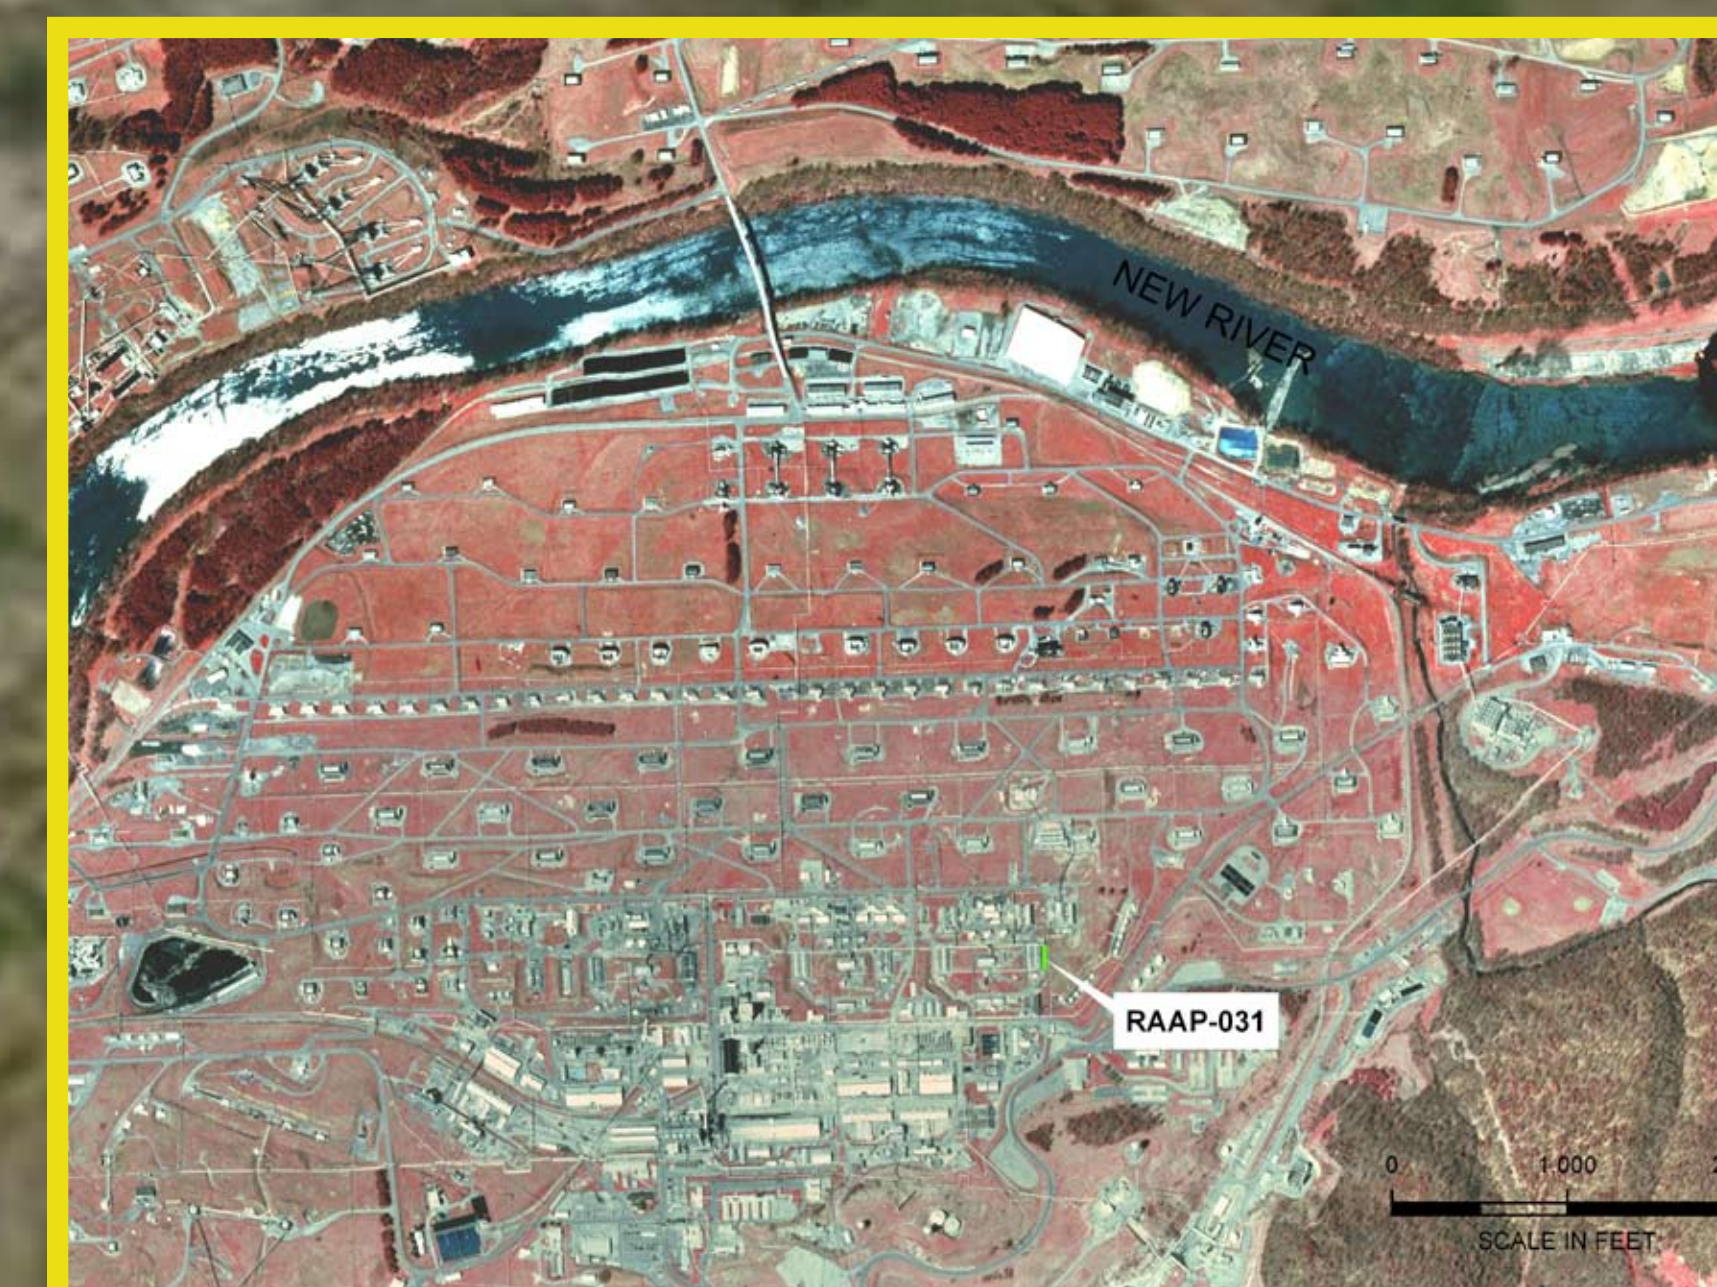
AOC A

- Former unlined surface drainage ditch identified in the mid 1980s
- Listed for site screening in the 1990s by which time a concrete swale had been installed

(RAAP-031)
Nitrocellulose Rainwater Ditch

- Site Screening Process identified dinitrotoluene and PCBs in soil greater than screening levels
- RCRA Facility Investigation (RFI) is ongoing and will delineate dinitrotoluene and PCBs in soil
 - Initial sampling conducted in July 2008
 - Follow-on sampling will be conducted in December 2008
- No effects to groundwater are expected based on concentrations detected in soil
- On track to complete Corrective Action by March 2010
