# Radford Army Ammunition Plant

## NEW RIVER UNIT (NRU)

### History

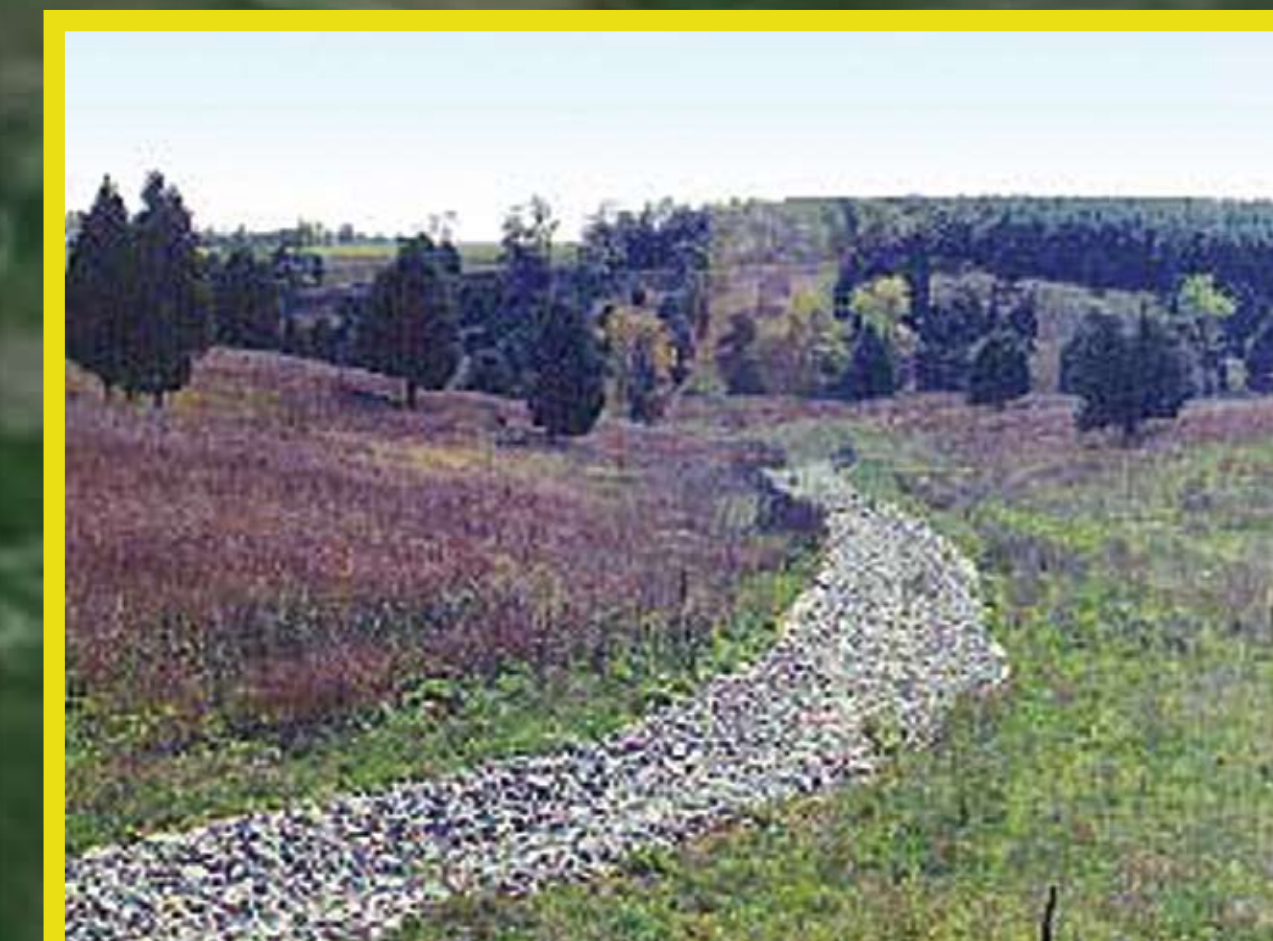
- The Building Debris Disposal Trench (BDDT) is located in the southern portion of the RFAAP-NRU and was originally a natural surface water drainage channel

- The BDDT was formerly used as a disposal site for construction debris from the RFAAP-NRU buildings
- The construction debris and visibly stained soil was removed from the trench in 1998. The excavated soils were replaced with clean fill and the base of the trench was lined with a geotextile material. The trench was then filled with rip-rap to prevent erosion.

- Investigations at site have focused on PAH detections in soil downgradient of the trench and potential impacts to a downgradient unnamed creek.
- PAH detections typically confined to surface soils (i.e., 0-1 ft bgs) with a limited area extending to a depth of approximately 3-4 ft bgs. PAH concentrations exceeding residential and industrial screening levels have been delineated.

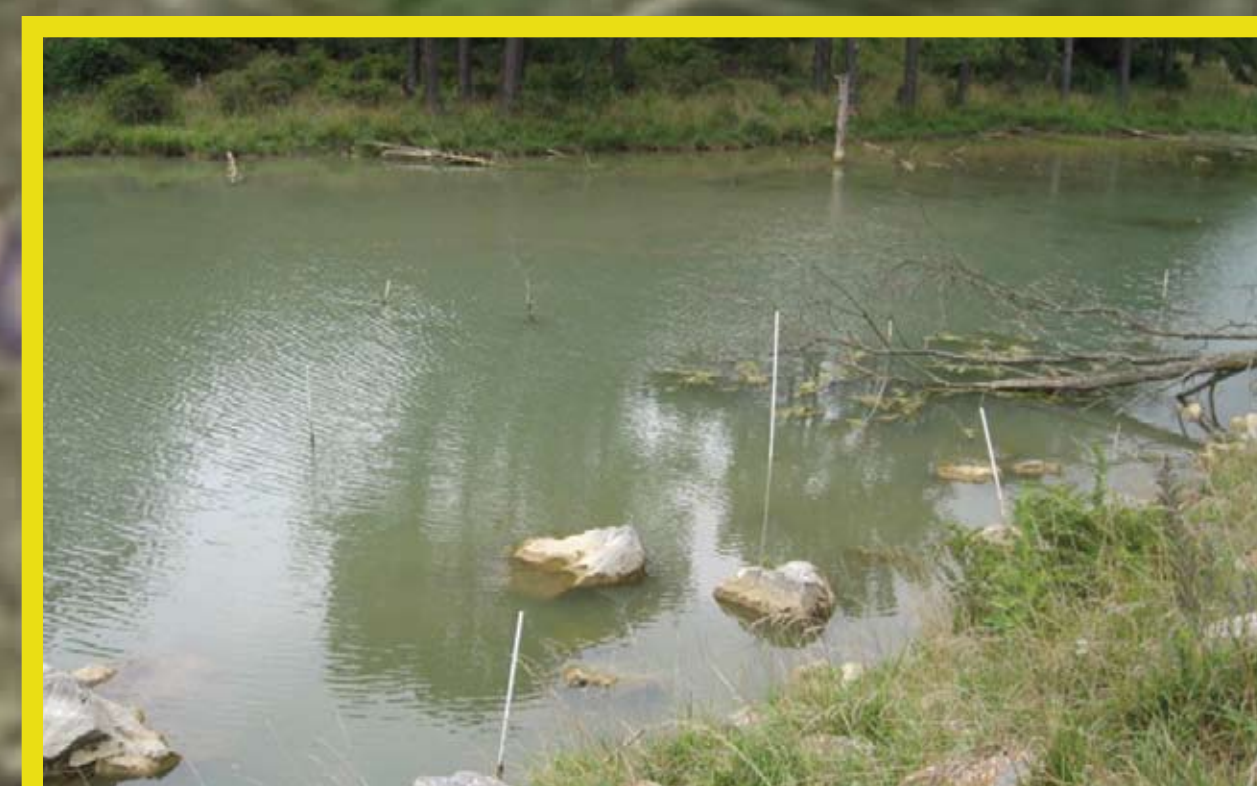
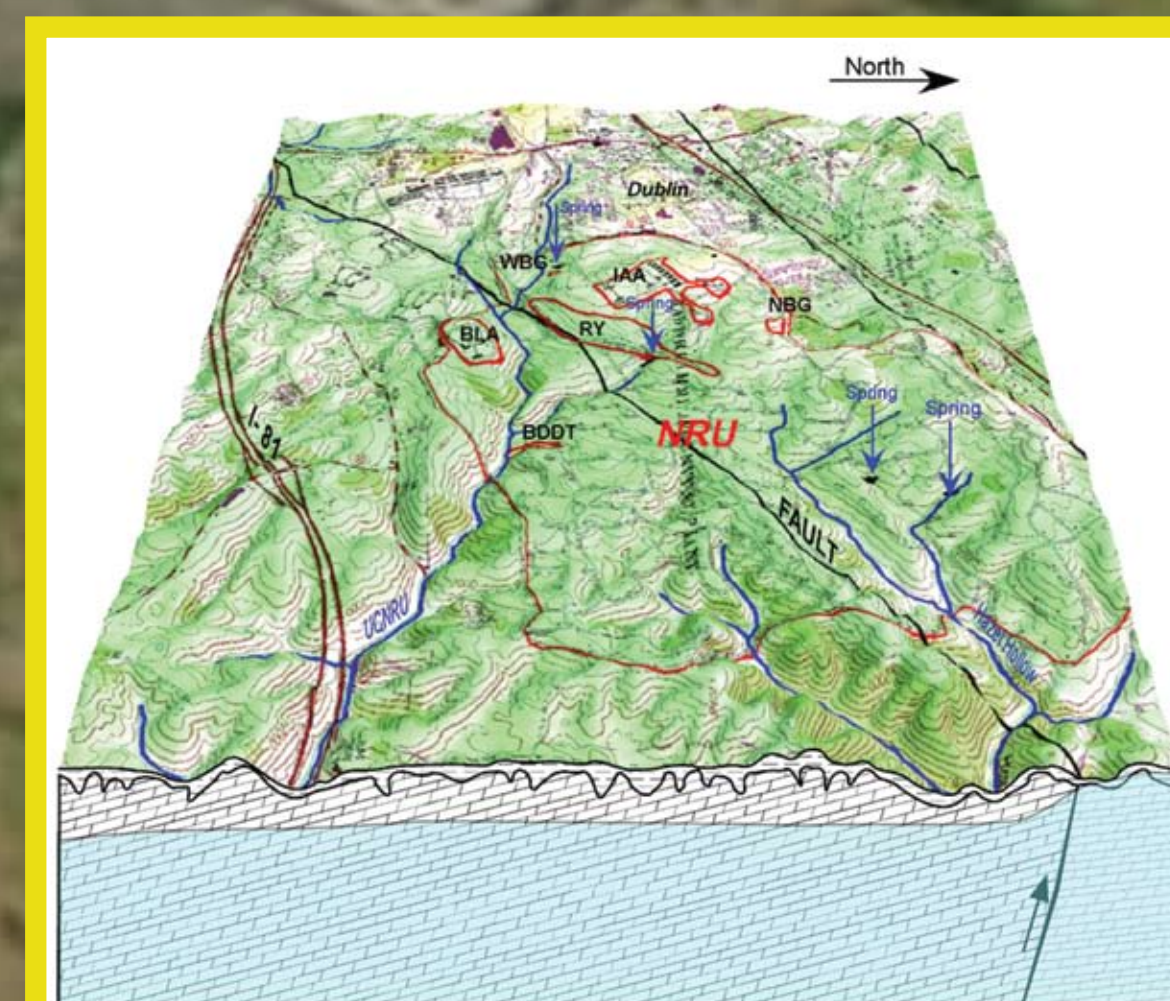
- The two burning grounds were used to decontaminate explosives contaminated materials and to dispose of off-spec energetics.
- **WBG**
  - A test pitting investigation was completed at the WBG in 1999 that effectively removed soils above residential screening levels in the source area.

- Lead was detected in an ashy layer of material beneath the road within the WBG at concentrations greater than the residential screening level.
  - Arsenic, lead, chromium and iron were detected in pond sediments at concentrations greater than industrial screening levels.

- Various PAHs were detected at concentrations greater than industrial screening levels in stream sediments downgradient of the pond and in soil within the site drainage ditch.

- Remedial Actions: To be determined.
- **NBG**
  - Lead and chromium detected at concentrations greater than industrial screening levels have been identified as the primary constituents of concern at the site.
